Intersection ID: N/A	Main Street: HOOVER_CREEK_BV	Cross Street: N/A	Location:	SE
ADA ID: 1D9DB63EB9E5	Ramp Type: PerpDiag	Initial Pass/Fail: Fail	Overall Compliance: No	Severity Score: 8.75

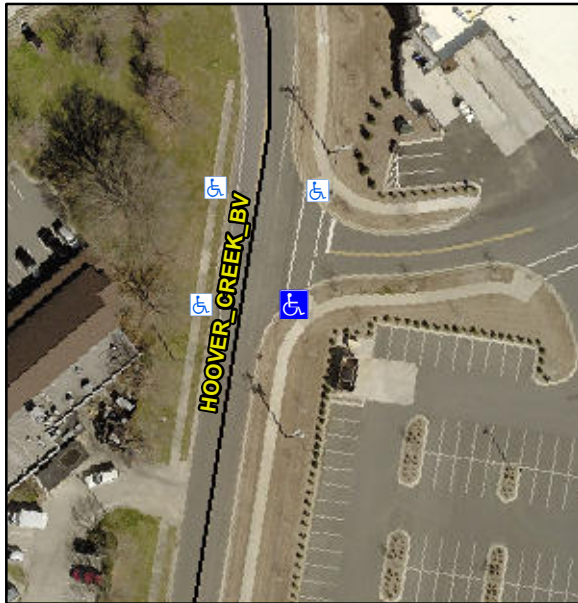
**Not Found, R304.5.1**

Compliance	Description	Data	Compliance	Description	Data
N/A	Ramp Length (in)	96.0	Yes	Ramp Slope (%)	6.4
No	Ramp Width (in)	38.0	Yes	Ramp XSlope (%)	0.1
N/A	Flare Type LT	N/A	N/A	Flare Type RT	N/A
N/A	Flare Slope LT (%)	N/A	N/A	Flare Slope RT (%)	N/A
N/A	Flare Traversable LT?	N/A	N/A	Flare Traversable RT?	N/A
N/A	Landing Length (in)	N/A	N/A	DWS Provided?	N/A
N/A	Landing Width (in)	N/A	N/A	DWS Contrast?	N/A
N/A	Landing Slope (%)	N/A	N/A	DWS Length (in)	N/A
N/A	Landing X Slope (%)	N/A	N/A	DWS Full Width?	N/A
N/A	Landing Curb? (Y/N)	N/A	N/A	DWS Offset (in)	N/A
N/A	Shared Landing?	N/A			
N/A	Gutter Ponding?	N/A	N/A	Gutter Slope (%)	N/A
N/A	Gutter Lip Ht (in)	N/A	N/A	Gutter X Slope (%)	N/A
N/A	Painted X Walk1?	Yes	N/A	Painted X Walk2?	No
	X Walk 1 Direction	To NE		X Walk 2 Direction	To NW
N/A	X Walk 1 Width (in)	120.0	N/A	X Walk 2 Width (in)	N/A
	X Walk 1 Slope (%)	0.5		X Walk 2 Slope (%)	3.3
	X Walk 1 X Slope (%)	2.0		X Walk 2 X Slope (%)	0.3

N/A	Ramp inside XWalk1?	Yes	N/A	Ramp inside XWalk2?	N/A
	Road Slope (%)	0.5	N/A	Clear Space?	N/A
	Road X Slope (%)	1.3	N/A	Clear Space to XWalk (in)	N/A
N/A	Any Obstructions?	N/A	N/A	Storm Grate/Utility Hazard?	N/A
	Obstruction Type			Storm Grate/Utility Type	
		N/A			N/A
			Yes	Surface Condition? (G/P)	Good

**Remove & Replace Curb Ramp With Two New Directional Ramps or Equivalent.**

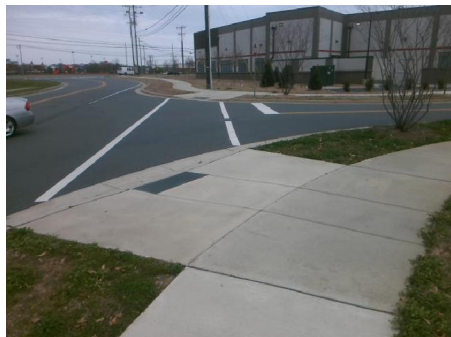
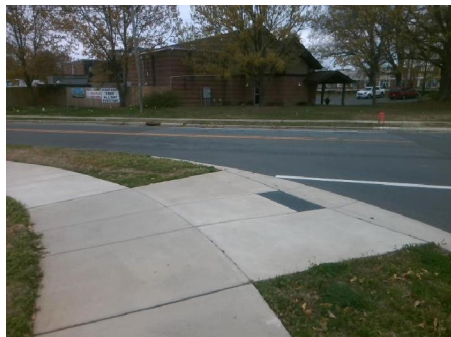
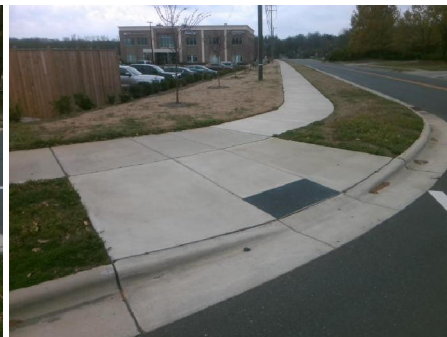
Street 1 Name	ENTRANCE
Stop Condition-Street 2	StopSign
Street 2 Name	HOOVER CREEK BV
Stop Condition-Street 1	None
