Access Compliance Report

Public Rights-of-Way

(Curb Ramps)

Intersection ID: 4420	Main Street: LARKHULL_DR	Cross Street: TRINITY_RD	Location:	S
ADA ID: 1D9FC4511247	Ramp Type: Perp	Initial Pass/Fail: Fail	Overall Compliance: No	Severity Score: 8.75
Codes/Mitigation Info/Possible Solution		Field Measurements/Component Compliance

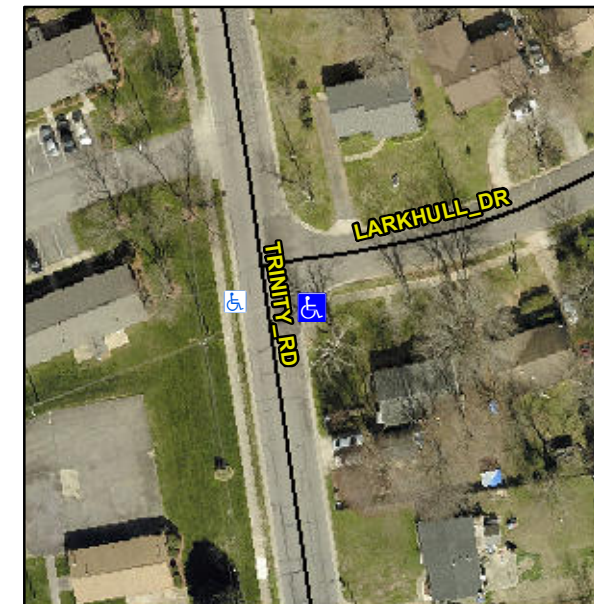
Not Found, R304.5.1

Compliance	Description	Data	Compliance	Description	Data
N/A	Ramp Length (in)	70.5	Yes	Ramp Slope (%)	7.7
No	Ramp Width (in)	40.0	Yes	Ramp XSlope (%)	1.4
N/A	Flare Type LT	N/A	N/A	Flare Type RT	N/A
N/A	Flare Slope LT (%)	N/A	N/A	Flare Slope RT (%)	N/A
N/A	Flare Traversable LT?	N/A	N/A	Flare Traversable RT?	N/A
N/A	Landing Length (in)	N/A	N/A	DWS Provided?	N/A
N/A	Landing Width (in)	N/A	N/A	DWS Contrast?	N/A
N/A	Landing Slope (%)	N/A	N/A	DWS Length (in)	N/A
N/A	Landing X Slope (%)	N/A	N/A	DWS Full Width?	N/A
N/A	Landing Curb? (Y/N)	N/A	N/A	DWS Offset (in)	N/A
N/A	Shared Landing?	N/A			
N/A	Gutter Ponding?	N/A	N/A	Gutter Slope (%)	N/A
N/A	Gutter Lip Ht (in)	N/A	N/A	Gutter X Slope (%)	N/A
N/A	Painted X Walk1?	No	N/A	Painted X Walk2?	N/A
	X Walk 1 Direction	To N		X Walk 2 Direction	N/A
N/A	X Walk 1 Width (in)	N/A	N/A	X Walk 2 Width (in)	N/A
	X Walk 1 Slope (%)	7.2		X Walk 2 Slope (%)	N/A
	X Walk 1 X Slope (%)	0.7		X Walk 2 X Slope (%)	N/A

N/A	Ramp inside XWalk1?	N/A	N/A	Ramp inside XWalk2?	N/A
	Road Slope (%)	N/A	N/A	Clear Space?	N/A
	Road X Slope (%)	N/A	N/A	Clear Space to XWalk (in)	N/A
N/A	Any Obstructions?	N/A	N/A	Storm Grate/Utility Hazard?	N/A
	Obstruction Type			Storm Grate/Utility Type	
		N/A			N/A
			Yes	Surface Condition? (G/P)	Good

Remove & Replace Entire Ramp.
