Intersection ID: 8373	Main Street: AUGUSTA_ST	Cross Street: LASALLE_ST	Location:	NW
ADA ID: 1DA765F7325C	Ramp Type: PerpDiag	Initial Pass/Fail: Fail	Overall Compliance: No	Severity Score: 35

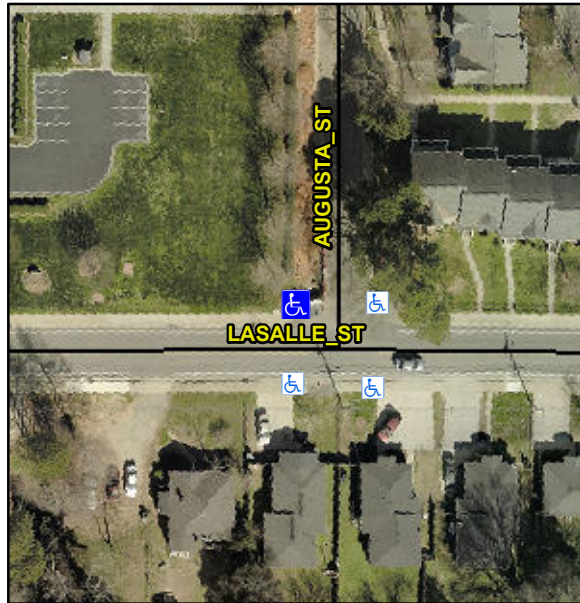
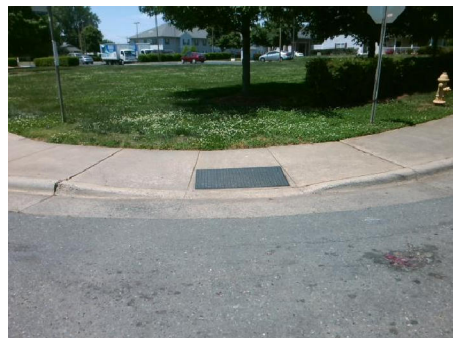
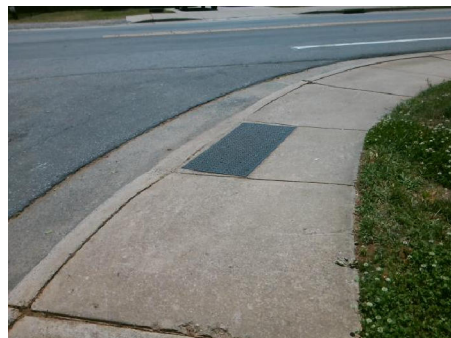
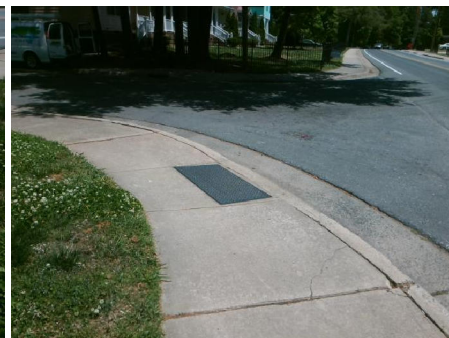
**Not Found, R304.5.1, R304.2.2,
R304.5.3**

Compliance	Description	Data	Compliance	Description	Data
N/A	Ramp Length (in)	59.0	No	Ramp Slope (%)	13.4
No	Ramp Width (in)	44.0	No	Ramp XSlope (%)	2.6
N/A	Flare Type LT	N/A	N/A	Flare Type RT	N/A
N/A	Flare Slope LT (%)	N/A	N/A	Flare Slope RT (%)	N/A
N/A	Flare Traversable LT?	N/A	N/A	Flare Traversable RT?	N/A
N/A	Landing Length (in)	N/A	N/A	DWS Provided?	N/A
N/A	Landing Width (in)	N/A	N/A	DWS Contrast?	N/A
N/A	Landing Slope (%)	N/A	N/A	DWS Length (in)	N/A
N/A	Landing X Slope (%)	N/A	N/A	DWS Full Width?	N/A
N/A	Landing Curb? (Y/N)	N/A	N/A	DWS Offset (in)	N/A
N/A	Shared Landing?	N/A			
N/A	Gutter Ponding?	N/A	N/A	Gutter Slope (%)	N/A
N/A	Gutter Lip Ht (in)	0.5	N/A	Gutter X Slope (%)	N/A
N/A	Painted X Walk1?	No	N/A	Painted X Walk2?	No
	X Walk 1 Direction	To S		X Walk 2 Direction	To E
N/A	X Walk 1 Width (in)	N/A	N/A	X Walk 2 Width (in)	N/A
	X Walk 1 Slope (%)	1.4		X Walk 2 Slope (%)	0.6
	X Walk 1 X Slope (%)	1.1		X Walk 2 X Slope (%)	1.1

N/A	Ramp inside XWalk1?	N/A	N/A	Ramp inside XWalk2?	N/A
	Road Slope (%)	1.8	N/A	Clear Space?	N/A
	Road X Slope (%)	6.2	N/A	Clear Space to XWalk (in)	N/A
N/A	Any Obstructions?	N/A	N/A	Storm Grate/Utility Hazard?	N/A
	Obstruction Type			Storm Grate/Utility Type	
		N/A			N/A
			Yes	Surface Condition? (G/P)	Good

Remove & Replace Curb Ramp With Two New Directional Ramps or Equivalent.
