Access Compliance Report Public Rights-of-Way (Curb Ramps)

Intersection ID: 10040 Main Street: HAZEL_ST Cross Street: TUCKASEEGEE_RD Location: NW

Severity Score: 58.75 **ADA ID: 1DAE6A69DDF8** Ramp Type: Perp Initial Pass/Fail: Fail **Overall Compliance: No**

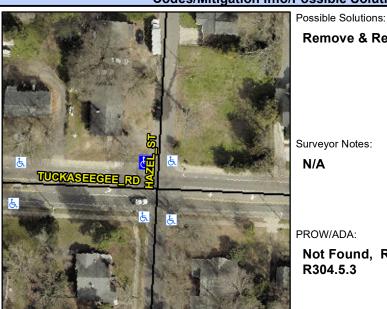
Field Measurements/Component Compliance								
Compli	ance Description	Data	Compli	iance	Description	Data		
N/A	Ramp Length (in)	47.0	No	Ramp	Slope (%)	16.3		
No	Ramp Width (in)	42.0	No	Ramp	XSlope (%)	9.2		
N/A	Flare Type LT	N/A	N/A	Flare	Type RT	N/A		
N/A	Flare Slope LT (%)	N/A	N/A	Flare	Slope RT (%)	N/A		
N/A	Flare Traversable LT?	N/A	N/A	Flare	Traversable RT?	N/A		
N/A	Landing Length (in)	N/A	N/A	DWS	Provided?	N/A		
N/A	Landing Width (in)	N/A	N/A	DWS	Contrast?	N/A		
N/A	Landing Slope (%)	N/A	N/A	DWS	Length (in)	N/A		
N/A	Landing X Slope (%)	N/A	N/A	DWS	Full Width?	N/A		
N/A	Landing Curb? (Y/N)	N/A	N/A	DWS	Offset (in)	N/A		
N/A	Shared Landing?	N/A						
N/A	Gutter Ponding?	Yes	N/A	Gutte	r Slope (%)	N/A		
N/A	Gutter Lip Ht (in)	N/A	N/A	Gutte	r X Slope (%)	N/A		
N/A	Painted X Walk1?	No	N/A	Paint	ed X Walk2?	N/A		
	X Walk 1 Direction	To E		X Wa	lk 2 Direction	N/A		
N/A	X Walk 1 Width (in)	N/A	N/A	X Wa	lk 2 Width (in)	N/A

X Walk 1 Slope (%)	1.0		X Wa	lk 2 Slope (%)	N/A		
	X Walk 1 X Slope (%)	10.3		X Wa	lk 2 X Slope (%)	N/A		
N/A	Ramp inside XWalk1?	N/A	N/A	Ramp	inside XWalk2?	N/A		
	Road Slope (%)	N/A	N/A	Clear	Space?	N/A		
	Road X Slope (%)	N/A	N/A	Clear	Space to XWalk (in)	N/A		
N/A	Any Obstructions?	N/A	N/A	Storm	Grate/Utility Hazard?	N/A		
	Obstruction Type			Storm	Grate/Utility Type			
		N/A				N/A		
			Yes	Surfa	ce Condition? (G/P)	Good

Remove & Replace Entire Ramp.							
l								
ì								
ļ								
d								
	Surveyor Notes:							
400	N/A							
	PROW/ADA:							
	Not Found, R304.5.1, R304.2.2,							
į	R304.5.3							
1
