Access Compliance Report

Public Rights-of-Way

(Curb Ramps)

Intersection ID: 7131	Main Street: N_TRYON_ST	Cross Street: ORCHARD_TRACE_LN	Location: W
ADA ID: 1DB24B7D0929	Ramp Type: Directional1	Initial Pass/Fail: Fail	Overall Compliance: No
Severity Score: 12.5			
Codes/Mitigation Info/Possible Solution		Field Measurements/Component Compliance

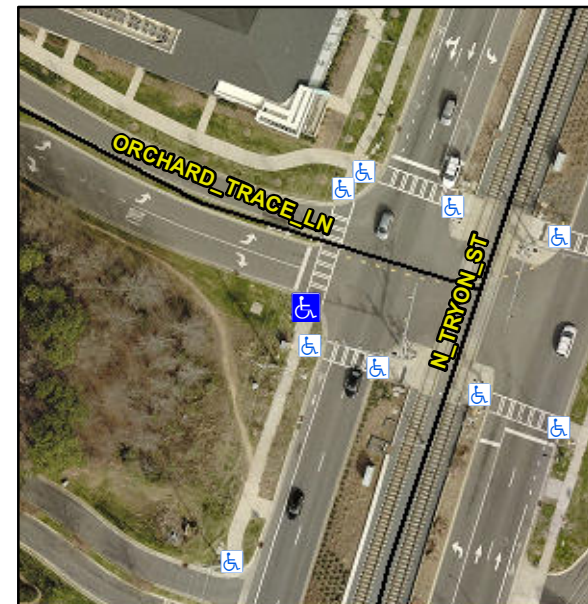
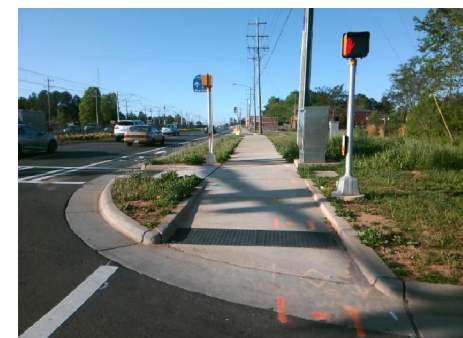
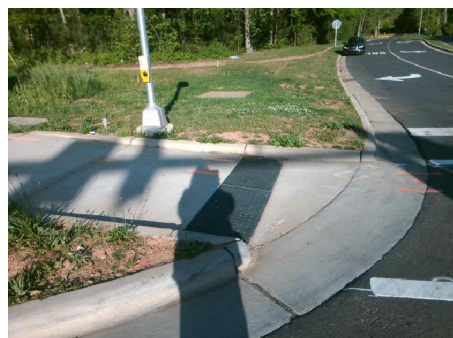
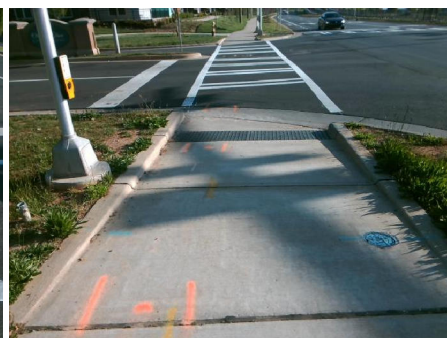
R304.2.2

Compliance	Description	Data	Compliance	Description	Data
N/A	Ramp Length (in)	167.0	N/A	Grade Break?	N/A
Yes	Ramp Width (in)	94.0	N/A	Grade Break Slope (%)	0.0
No	Ramp Slope (%)	8.8	N/A	Grade Break XSlope (%)	0.0
Yes	Ramp XSlope (%)	1.4			
N/A	Flare Type LT	N/A	N/A	Flare Type RT	N/A
N/A	Flare Slope LT (%)	N/A	N/A	Flare Slope RT (%)	0.0
N/A	Flare Traversable LT?	N/A	N/A	Flare Traversable RT?	N/A
N/A	Landing Length (in)	0.0	N/A	DWS Provided?	N/A
N/A	Landing Width (in)	0.0	N/A	DWS Contrast?	N/A
N/A	Landing Slope (%)	0.0	N/A	DWS Length (in)	N/A
N/A	Landing X Slope (%)	0.0	N/A	DWS Full Width?	N/A
N/A	Landing Curb? (Y/N)	N/A	N/A	DWS Offset LT (in)	N/A
N/A	Shared Landing?	N/A	N/A	DWS Offset RT (in)	N/A
N/A	Gutter Ponding?	0.0	N/A	Gutter Slope (%)	N/A
N/A	Gutter Lip Ht (in)	0.0	N/A	Gutter X Slope (%)	N/A
N/A	Painted X Walk1?	Yes		Road Slope (%)	2.9
	X Walk 1 Direction	To NE		Road X Slope (%)	3.6
	X Walk 1 Width (in)	100.0		Clear Space?	N/A

X Walk 1 Slope (%)	2.9	N/A	Clear Space to XWalk (in)	N/A
	X Walk 1 X Slope (%)	3.6	N/A	Storm Grate/Utility Hazard?	N/A
N/A	Ramp inside XWalk1?	Yes		Storm Grate/Utility Type	
N/A	Any Obstructions?	N/A			N/A
	Obstruction Type		Yes	Surface Condition? (G/P)	Good
			N/A	Curb Slope (%)	7.3

Possible Solutions:

Remove & Replace Entire Ramp.
