# Access Compliance Report

## Public Rights-of-Way

### (Curb Ramps)

Intersection ID: 2910	Main Street: RIDGEFIELD_DR	Cross Street: SWANSTON_DR	Location: NW
ADA ID: 1DB6F88C388B	Ramp Type: PerpDiag	Initial Pass/Fail: Fail	Overall Compliance: No
		Severity Score: 10

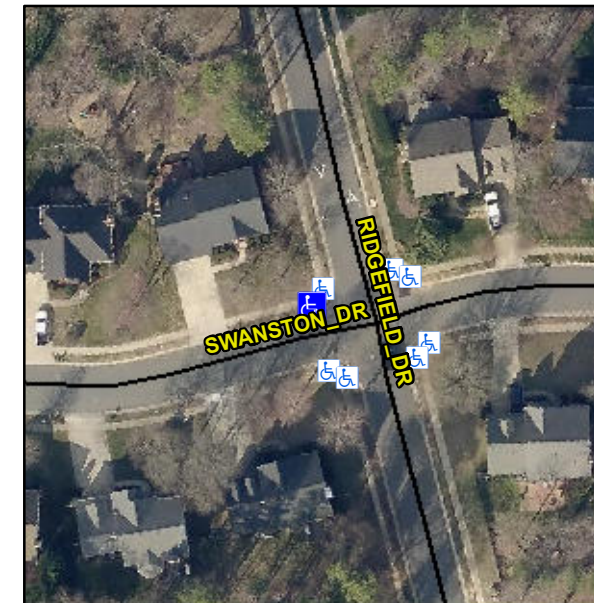
**Not Found, R304.5.1, R304.5.3**

Compliance	Description	Data	Compliance	Description	Data
N/A	Ramp Length (in)	48.0	Yes	Ramp Slope (%)	6.6
No	Ramp Width (in)	38.0	No	Ramp XSlope (%)	3.0
N/A	Flare Type LT	N/A	N/A	Flare Type RT	N/A
N/A	Flare Slope LT (%)	N/A	N/A	Flare Slope RT (%)	N/A
N/A	Flare Traversable LT?	N/A	N/A	Flare Traversable RT?	N/A
N/A	Landing Length (in)	N/A	N/A	DWS Provided?	N/A
N/A	Landing Width (in)	N/A	N/A	DWS Contrast?	N/A
N/A	Landing Slope (%)	N/A	N/A	DWS Length (in)	N/A
N/A	Landing X Slope (%)	N/A	N/A	DWS Full Width?	N/A
N/A	Landing Curb? (Y/N)	N/A	N/A	DWS Offset (in)	N/A
N/A	Shared Landing?	N/A			
N/A	Gutter Ponding?	N/A	N/A	Gutter Slope (%)	N/A
N/A	Gutter Lip Ht (in)	N/A	N/A	Gutter X Slope (%)	N/A
N/A	Painted X Walk1?	No	N/A	Painted X Walk2?	No
	X Walk 1 Direction	To S		X Walk 2 Direction	To E
N/A	X Walk 1 Width (in)	N/A	N/A	X Walk 2 Width (in)	N/A
	X Walk 1 Slope (%)	1.3		X Walk 2 Slope (%)	1.3
	X Walk 1 X Slope (%)	2.3		X Walk 2 X Slope (%)	2.1

N/A	Ramp inside XWalk1?	N/A	N/A	Ramp inside XWalk2?	N/A
	Road Slope (%)	1.2	N/A	Clear Space?	N/A
	Road X Slope (%)	5.6	N/A	Clear Space to XWalk (in)	N/A
N/A	Any Obstructions?	N/A	N/A	Storm Grate/Utility Hazard?	N/A
	Obstruction Type			Storm Grate/Utility Type	
		N/A			N/A
			Yes	Surface Condition? (G/P)	Good

**Remove & Replace Curb Ramp With Two New Directional Ramps or Equivalent.**
