# Access Compliance Report

## Public Rights-of-Way

### (Curb Ramps)

Intersection ID: 25211	Main Street: SMITH_RD	Cross Street: SOUTHBRIDGE_FOREST_DR	Location: NE
ADA ID: 1DCD643CEE03	Ramp Type: Perp	Initial Pass/Fail: Fail	Overall Compliance: No
		Severity Score: 25

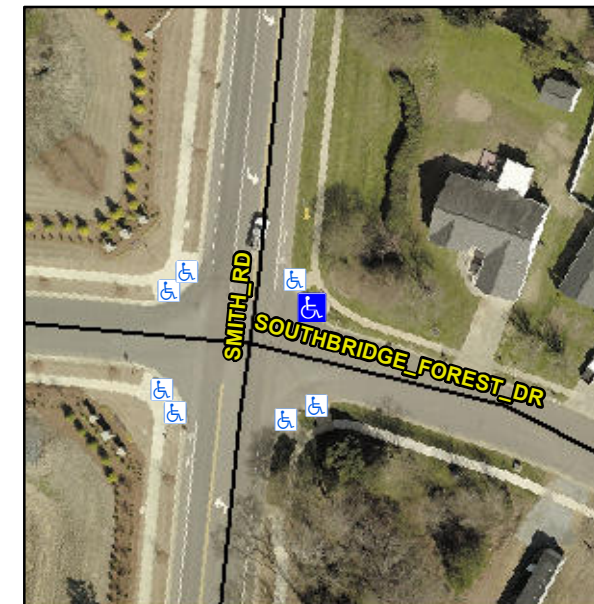
**Not Found, R304.2.2, R304.5.3**

Compliance	Description	Data	Compliance	Description	Data
N/A	Ramp Length (in)	102.0	No	Ramp Slope (%)	9.2
Yes	Ramp Width (in)	101.0	No	Ramp XSlope (%)	6.2
N/A	Flare Type LT	N/A	N/A	Flare Type RT	N/A
N/A	Flare Slope LT (%)	N/A	N/A	Flare Slope RT (%)	N/A
N/A	Flare Traversable LT?	N/A	N/A	Flare Traversable RT?	N/A
N/A	Landing Length (in)	N/A	N/A	DWS Provided?	N/A
N/A	Landing Width (in)	N/A	N/A	DWS Contrast?	N/A
N/A	Landing Slope (%)	N/A	N/A	DWS Length (in)	N/A
N/A	Landing X Slope (%)	N/A	N/A	DWS Full Width?	N/A
N/A	Landing Curb? (Y/N)	N/A	N/A	DWS Offset (in)	N/A
N/A	Shared Landing?	N/A			
N/A	Gutter Ponding?	N/A	N/A	Gutter Slope (%)	N/A
N/A	Gutter Lip Ht (in)	N/A	N/A	Gutter X Slope (%)	N/A
N/A	Painted X Walk1?	No	N/A	Painted X Walk2?	N/A
	X Walk 1 Direction	To SW		X Walk 2 Direction	N/A
N/A	X Walk 1 Width (in)	N/A	N/A	X Walk 2 Width (in)	N/A
	X Walk 1 Slope (%)	4.7		X Walk 2 Slope (%)	N/A
	X Walk 1 X Slope (%)	3.8		X Walk 2 X Slope (%)	N/A

N/A	Ramp inside XWalk1?	N/A	N/A	Ramp inside XWalk2?	N/A
	Road Slope (%)	N/A	N/A	Clear Space?	N/A
	Road X Slope (%)	N/A	N/A	Clear Space to XWalk (in)	N/A
N/A	Any Obstructions?	N/A	N/A	Storm Grate/Utility Hazard?	N/A
	Obstruction Type			Storm Grate/Utility Type	
		N/A			N/A
			Yes	Surface Condition? (G/P)	Good

Possible Solutions:

**Remove & Replace Entire Ramp.**

Total Cost: \$ 1850.00
