Access Compliance Report

Public Rights-of-Way

(Curb Ramps)

Intersection ID: 29243	Main Street: WOODINGTON_LN	Cross Street: CARRINGTON_HILL_DR	Location:	N
ADA ID: 1DCF994952AB	Ramp Type: BlendTrans1	Initial Pass/Fail: Fail	Overall Compliance: No	Severity Score: 10

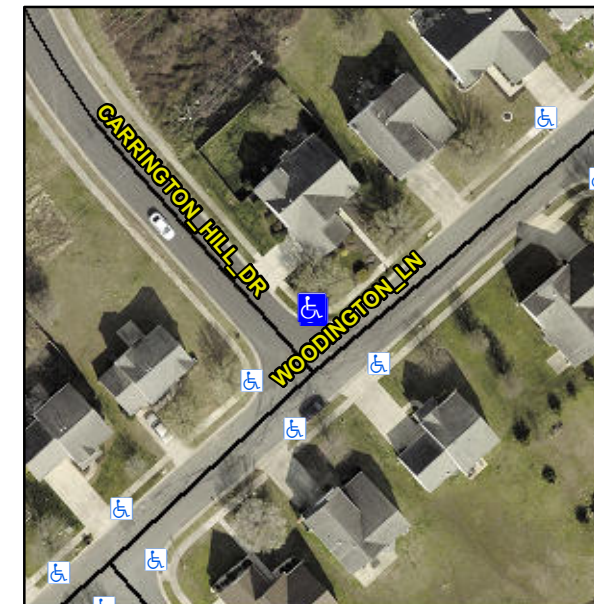
Not Found, R304.5.1, R304.5.3

Compliance	Description	Data	Compliance	Description	Data
N/A	Ramp Length (in)	48.0	Yes	BlendTrans Slope (%)	3.3
No	Ramp Width (in)	47.5	No	BlendTrans XSlope (%)	3.8
N/A	Flare Type LT	N/A	N/A	Flare Type RT	N/A
N/A	Flare Slope LT (%)	N/A	N/A	Flare Slope RT (%)	N/A
N/A	Flare Traversable LT?	N/A	N/A	Flare Traversable RT?	N/A
N/A	Landing Length (in)	N/A	N/A	DWS Provided?	N/A
N/A	Landing Width (in)	N/A	N/A	DWS Contrast?	N/A
N/A	Landing Slope (%)	N/A	N/A	DWS Length (in)	N/A
N/A	Landing X Slope (%)	N/A	N/A	DWS Full Width?	N/A
N/A	Landing Curb? (Y/N)	N/A	N/A	DWS Offset (in)	N/A
N/A	Shared Landing?	N/A			
N/A	Gutter Ponding?	N/A	N/A	Gutter Slope (%)	N/A
N/A	Gutter Lip Ht (in)	N/A	N/A	Gutter X Slope (%)	N/A
N/A	Painted X Walk1?	No	N/A	Painted X Walk2?	No
	X Walk 1 Direction	To SW		X Walk 2 Direction	To SE
	X Walk 1 Width (in)	N/A		X Walk 2 Width (in)	N/A
	X Walk 1 Slope (%)	3.9		X Walk 2 Slope (%)	4.5
	X Walk 1 X Slope (%)	4.1		X Walk 2 X Slope (%)	6.0

N/A	Ramp inside XWalk1?	N/A	N/A	Ramp inside XWalk2?	N/A
	Road Slope (%)	1.1		Clear Space?	N/A
	Road X Slope (%)	8.8	N/A	Clear Space to XWalk (in)	N/A
N/A	Any Obstructions?	N/A	N/A	Storm Grate/Utility Hazard?	N/A
	Obstruction Type			Storm Grate/Utility Type	
		N/A			N/A
			Yes	Surface Condition? (G/P)	Good
			No	Curb Slope (%)	6.1

Remove & Replace Curb Ramp With Two New Directional Ramps or Equivalent.
