# Access Compliance Report

## Public Rights-of-Way

### (Curb Ramps)

Intersection ID: 4877	Main Street: GRANARD_LN	Cross Street: HARRINGTON_WOODS_RD	Location: W
ADA ID: 1DD41FB8051D	Ramp Type: Perp	Initial Pass/Fail: Fail	Overall Compliance: No
Severity Score: 12.5			
Codes/Mitigation Info/Possible Solution		Field Measurements/Component Compliance

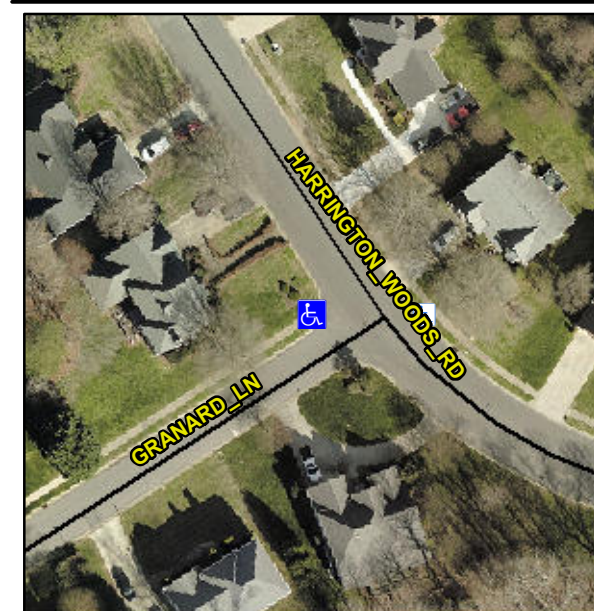
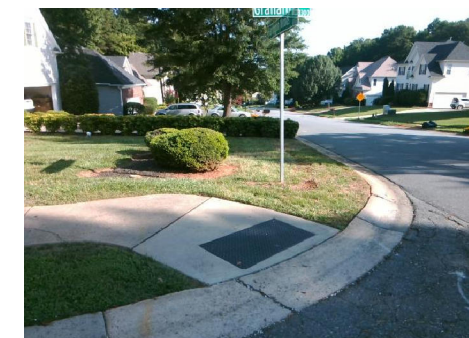
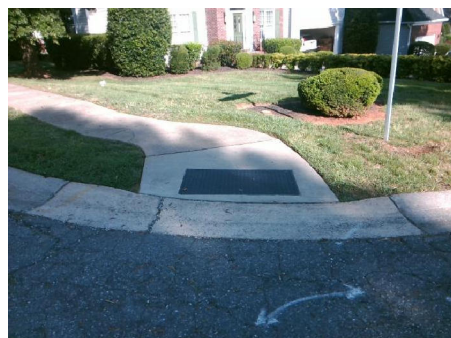
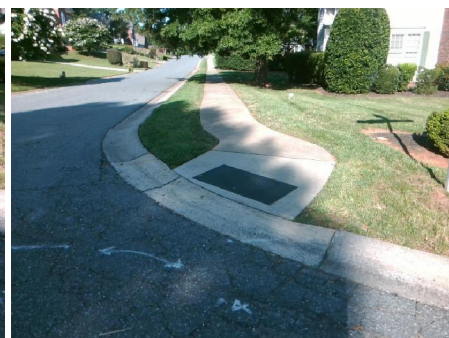
Compliance	Description	Data	Compliance	Description	Data
N/A	Ramp Length (in)	38.0	Yes	Ramp Slope (%)	8.0
Yes	Ramp Width (in)	48.0	No	Ramp XSlope (%)	5.5
N/A	Flare Type LT	N/A	N/A	Flare Type RT	N/A
N/A	Flare Slope LT (%)	N/A	N/A	Flare Slope RT (%)	N/A
N/A	Flare Traversable LT?	N/A	N/A	Flare Traversable RT?	N/A
N/A	Landing Length (in)	N/A	N/A	DWS Provided?	N/A
N/A	Landing Width (in)	N/A	N/A	DWS Contrast?	N/A
N/A	Landing Slope (%)	N/A	N/A	DWS Length (in)	N/A
N/A	Landing X Slope (%)	N/A	N/A	DWS Full Width?	N/A
N/A	Landing Curb? (Y/N)	N/A	N/A	DWS Offset (in)	N/A
N/A	Shared Landing?	N/A			
N/A	Gutter Ponding?	N/A	N/A	Gutter Slope (%)	N/A
N/A	Gutter Lip Ht (in)	N/A	N/A	Gutter X Slope (%)	N/A
N/A	Painted X Walk1?	No	N/A	Painted X Walk2?	N/A
	X Walk 1 Direction	To SE		X Walk 2 Direction	N/A
N/A	X Walk 1 Width (in)	N/A	N/A	X Walk 2 Width (in)	N/A
	X Walk 1 Slope (%)	5.2		X Walk 2 Slope (%)	N/A
	X Walk 1 X Slope (%)	4.7		X Walk 2 X Slope (%)	N/A

N/A	Ramp inside XWalk1?	N/A	N/A	Ramp inside XWalk2?	N/A
	Road Slope (%)	N/A	N/A	Clear Space?	N/A
	Road X Slope (%)	N/A	N/A	Clear Space to XWalk (in)	N/A
N/A	Any Obstructions?	N/A	N/A	Storm Grate/Utility Hazard?	N/A
	Obstruction Type			Storm Grate/Utility Type	
		N/A			N/A
			Yes	Surface Condition? (G/P)	Good

**Remove & Replace Entire Ramp.**

**R304.5.3**
