Access Compliance Report

Public Rights-of-Way

(Curb Ramps)

Intersection ID: 17822	Main Street: CORDER_DR	Cross Street: PINEY_GROVE_RD	Location: NW
ADA ID: 1DDFA58F9790	Ramp Type: PerpDiag	Initial Pass/Fail: Fail	Overall Compliance: No
		Severity Score: 25

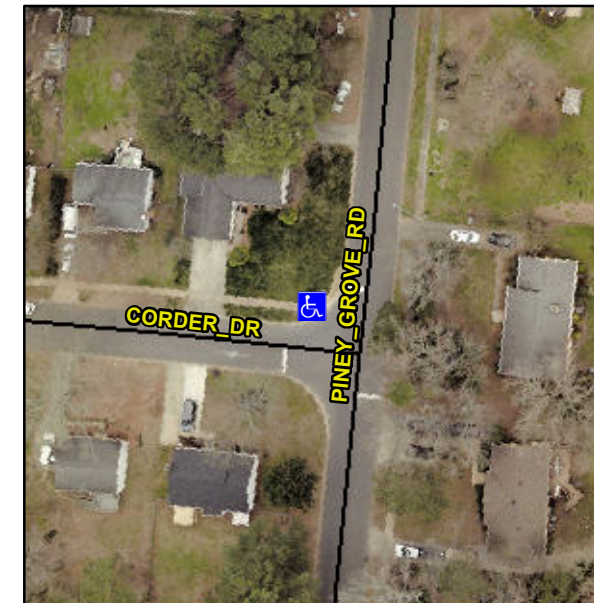
Not Found, R304.2.2

Compliance	Description	Data	Compliance	Description	Data
N/A	Ramp Length (in)	25.0	No	Ramp Slope (%)	14.3
Yes	Ramp Width (in)	48.0	Yes	Ramp XSlope (%)	1.3
N/A	Flare Type LT	N/A	N/A	Flare Type RT	N/A
N/A	Flare Slope LT (%)	N/A	N/A	Flare Slope RT (%)	N/A
N/A	Flare Traversable LT?	N/A	N/A	Flare Traversable RT?	N/A
N/A	Landing Length (in)	N/A	N/A	DWS Provided?	N/A
N/A	Landing Width (in)	N/A	N/A	DWS Contrast?	N/A
N/A	Landing Slope (%)	N/A	N/A	DWS Length (in)	N/A
N/A	Landing X Slope (%)	N/A	N/A	DWS Full Width?	N/A
N/A	Landing Curb? (Y/N)	N/A	N/A	DWS Offset (in)	N/A
N/A	Shared Landing?	N/A			
N/A	Gutter Ponding?	N/A	N/A	Gutter Slope (%)	N/A
N/A	Gutter Lip Ht (in)	N/A	N/A	Gutter X Slope (%)	N/A
N/A	Painted X Walk1?	No	N/A	Painted X Walk2?	No
	X Walk 1 Direction	To SW		X Walk 2 Direction	To SE
N/A	X Walk 1 Width (in)	N/A	N/A	X Walk 2 Width (in)	N/A
	X Walk 1 Slope (%)	1.7		X Walk 2 Slope (%)	4.2
	X Walk 1 X Slope (%)	1.0		X Walk 2 X Slope (%)	0.1

Remove & Replace Curb Ramp With Two New Directional Ramps or Equivalent.
