Access Compliance Report Public Rights-of-Way (Curb Ramps)

Intersection ID: 49925 Main Street: PAXTON_RUN_RD Cross Street: CAMPBELL_HALL_CT Location: SW

ADA ID: 1DE126D0B8F4 Ramp Type: Perp Initial Pass/Fail: Fail Overall Compliance: No Severity Score: 13.75

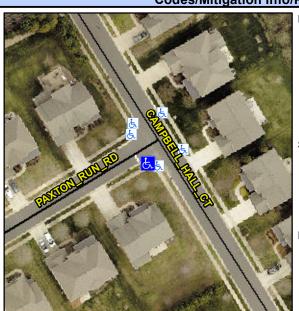
Not Found, R304.2.2, R304.5.3

No N/A Ramp Length (in) 45.0 Ramp Slope (%) 9.5 No Ramp XSlope (%) Yes Ramp Width (in) 48.0 2.2 N/A N/A Flare Type LT N/A Flare Type RT N/A N/A N/A N/A Flare Slope RT (%) N/A Flare Slope LT (%) N/A Flare Traversable LT? N/A N/A Flare Traversable RT? N/A N/A N/A N/A **DWS Provided?** N/A Landing Length (in) N/A Landing Width (in) N/A N/A **DWS Contrast?** N/A N/A N/A N/A Landing Slope (%) DWS Length (in) N/A N/A Landing X Slope (%) N/A N/A DWS Full Width? N/A N/A Landing Curb? (Y/N) N/A N/A DWS Offset (in) N/A N/A Shared Landing? **Gutter Ponding?** N/A N/A Gutter Slope (%) N/A Gutter Lip Ht (in) N/A N/A Gutter X Slope (%) N/A Painted X Walk1? No N/A Painted X Walk2? N/A X Walk 1 Direction To NW X Walk 2 Direction N/A N/A X Walk 1 Width (in) X Walk 2 Width (in) N/A X Walk 1 Slope (%) X Walk 2 Slope (%) N/A 0.4 X Walk 2 X Slope (%) X Walk 1 X Slope (%) 1.1 N/A N/A N/A Ramp inside XWalk1? Ramp inside XWalk2? N/A Road Slope (%) N/A N/A Clear Space? N/A Road X Slope (%) N/A N/A Clear Space to XWalk (in) N/A N/A Any Obstructions? N/A Storm Grate/Utility Hazard? N/A **Obstruction Type** Storm Grate/Utility Type N/A N/A Yes Surface Condition? (G/P) Good

Remove & Replace Entire Ramp.

Total Cost:
\$ 1850.00
