# Access Compliance Report

## Public Rights-of-Way (Curb Ramps)

Intersection ID: 14281	Main Street: E_KINGSTON_AV	Cross Street: LYNDHURST_AV	Location:	E
ADA ID: 1DFBFBADAFF1	Ramp Type: Directional1	Initial Pass/Fail: Fail	Overall Compliance: No	Severity Score: 12.5
Codes/Mitigation Info/Possible Solution		Field Measurements/Component Compliance

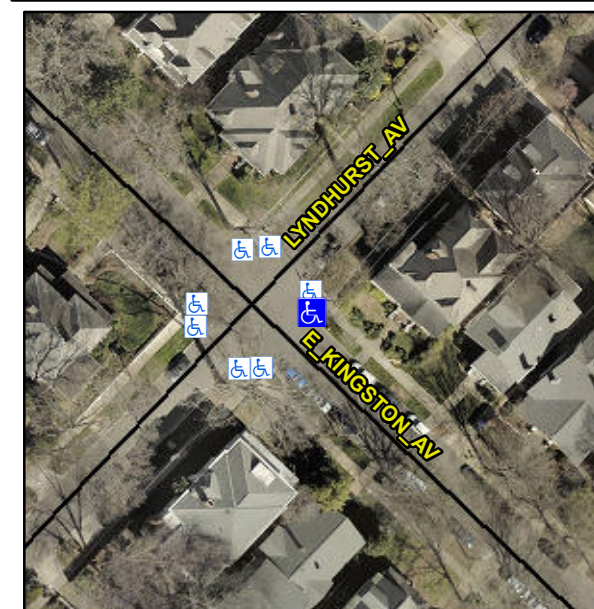
Compliance	Description	Data	Compliance	Description	Data
N/A	Ramp Length (in)	66.0	N/A	Grade Break?	N/A
Yes	Ramp Width (in)	48.0	N/A	Grade Break Slope (%)	0.0
Yes	Ramp Slope (%)	5.0	N/A	Grade Break XSlope (%)	0.0
No	Ramp XSlope (%)	5.4			
N/A	Flare Type LT	N/A	N/A	Flare Type RT	N/A
N/A	Flare Slope LT (%)	N/A	N/A	Flare Slope RT (%)	0.0
N/A	Flare Traversable LT?	N/A	N/A	Flare Traversable RT?	N/A
N/A	Landing Length (in)	0.0	N/A	DWS Provided?	N/A
N/A	Landing Width (in)	0.0	N/A	DWS Contrast?	N/A
N/A	Landing Slope (%)	0.0	N/A	DWS Length (in)	N/A
N/A	Landing X Slope (%)	0.0	N/A	DWS Full Width?	N/A
N/A	Landing Curb? (Y/N)	N/A	N/A	DWS Offset LT (in)	N/A
N/A	Shared Landing?	N/A	N/A	DWS Offset RT (in)	N/A
N/A	Gutter Ponding?	Yes	N/A	Gutter Slope (%)	N/A
N/A	Gutter Lip Ht (in)	1.0	N/A	Gutter X Slope (%)	N/A
N/A	Painted X Walk1?	No		Road Slope (%)	6.8
	X Walk 1 Direction	To SW		Road X Slope (%)	1.2
	X Walk 1 Width (in)	N/A		Clear Space?	N/A

X Walk 1 Slope (%)	6.8	N/A	Clear Space to XWalk (in)	N/A
	X Walk 1 X Slope (%)	1.2	N/A	Storm Grate/Utility Hazard?	N/A
N/A	Ramp inside XWalk1?	N/A		Storm Grate/Utility Type	
N/A	Any Obstructions?	N/A			N/A
	Obstruction Type		Yes	Surface Condition? (G/P)	Good
			N/A	Curb Slope (%)	1.3

**Remove & Replace Entire Ramp.**

**R304.5.3**

\$ 1600.00
