Access Compliance Report Public Rights-of-Way (Curb Ramps)

Intersection ID: 6943 Main Street: BEATTIES_FORD_RD			Cross	Street:	CINDY_LN	Location:	SW		
ADA ID: 1E03952B4EED	52B4EED Ramp Type: PerpDiag			nitial Pass/Fail: Fail Overall Compliance: No				o Severity Score:	13.75
Codes/Mitigation Info/Possible Solution				Field Measurements/Component Compliance					
	E CILIPITAL DE LE CILIPITAL DE	Possible Solutions:					a Compliance Description		Data

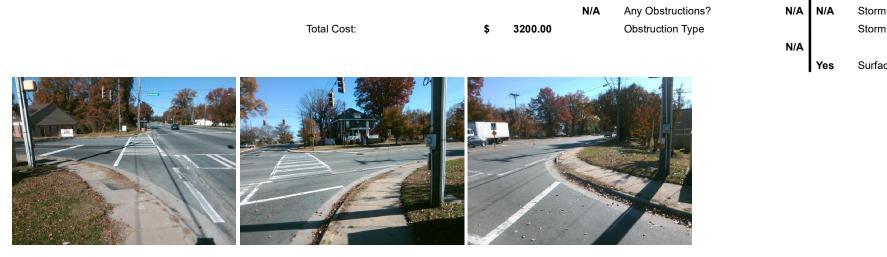
• 128		Remove & Replace Curb Ramp	With	N/A	Ramp Length (in)	55.0		Ramp Slope (%)	9.1
		Two New Directional Ramps or	vv itii	Yes	Ramp Width (in)	48.0	_	Ramp XSlope (%)	2.6
		Equivalent.		N/A	Flare Type LT	N/A		Flare Type RT	N/A

-		N/A	Flare Slope LT (%)		N/A	Flare Slope RT (%)	N/A
		5		N/A	Flare Traversable LT?	N/A		Flare Traversable RT?	N/A
WE RD		Surveyor Notes:		N/A	Landing Length (in)		N/A	DWS Provided?	N/A
TE CROUTE				N/A	Landing Width (in)	N/A		DWS Contrast?	N/A
GRUA		N/A		N/A	Landing Slope (%)		N/A	DWS Length (in)	N/A
		N/A		N/A	Landing X Slope (%)	N/A	N/A	DWS Full Width?	N/A
33 - 1 - A				N/A	• • • • •	N/A			N/A N/A
and the second					Landing Curb? (Y/N)		N/A	DWS Offset (in)	N/A
				N/A	Shared Landing?	N/A		O_{11}	N1/A
		PROW/ADA:		N/A	Gutter Ponding?		N/A	Gutter Slope (%)	N/A
		Not Found, R304.2.2, R304.5.3		N/A	Gutter Lip Ht (in)	N/A		Gutter X Slope (%)	N/A
No.	1 AVE 1 1			N/A	Painted X Walk1?		N/A	Painted X Walk2?	Yes
0	1 Plan 1				X Walk 1 Direction	To E		X Walk 2 Direction	To N
				N/A	X Walk 1 Width (in)	118.0	N/A	X Walk 2 Width (in)	101.0
Street 1 Name	BEATTIES FORD RD				X Walk 1 Slope (%)	0.3		X Walk 2 Slope (%)	4.1

Stop Condition-Street 2	Signal				X Walk 1 X Slope (%)	2.7		X Walk 2 X Slope (%)	0.8
Street 2 Name	CINDY LN			N/A	Ramp inside XWalk1?	Yes	N/A	Ramp inside XWalk2?	Yes
Stop Condition-Street 1	Signal				Road Slope (%)	0.3	N/A	Clear Space?	N/A
					Road X Slope (%)	2.3	N/A	Clear Space to XWalk (in)	N/A
				N/A	Any Obstructions?	N/A	N/A	Storm Grate/Utility Hazard?	N/A
		Total Cost: \$	3200.00		Obstruction Type			Storm Grate/Utility Type	
						N/A			N/A
