# Access Compliance Report

## Public Rights-of-Way

### (Curb Ramps)

Intersection ID: 12012	Main Street: PARSON_ST	Cross Street: KENNON_ST	Location: E
ADA ID: 1E05821AF1AD	Ramp Type: Perp	Initial Pass/Fail: Fail	Overall Compliance: No
			Severity Score: 36.25

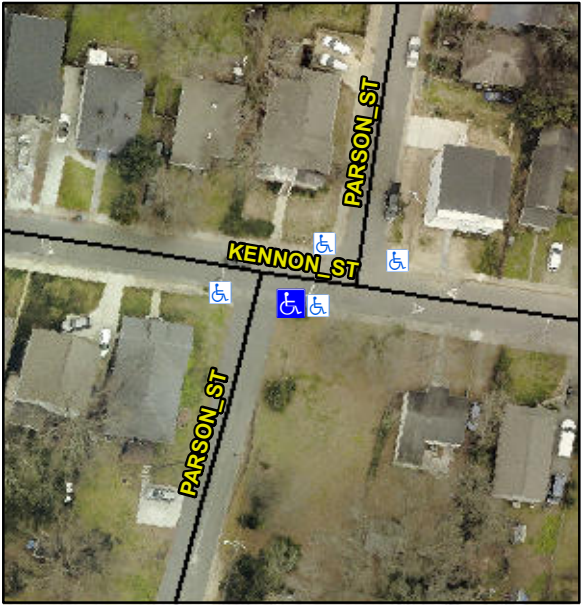
Possible Solutions:		<b>Compliance</b>	<b>Description</b>	<b>Data</b>
	<b>Remove &amp; Replace Entire Ramp.</b>		<b>Yes</b>	Ramp Slope (%)	<b>5.5</b>
			<b>No</b>	Ramp Width (in)	<b>4.7</b>
			<b>N/A</b>	Flare Type LT	<b>N/A</b>
			<b>N/A</b>	Flare Slope LT (%)	<b>N/A</b>
			<b>N/A</b>	Flare Traversable LT?	<b>N/A</b>
			<b>N/A</b>	Flare Type RT	<b>N/A</b>
			<b>N/A</b>	Flare Slope RT (%)	<b>N/A</b>
			<b>N/A</b>	Flare Traversable RT?	<b>N/A</b>
			<b>N/A</b>	DWS Provided?	<b>N/A</b>
			<b>N/A</b>	DWS Contrast?	<b>N/A</b>
			<b>N/A</b>	DWS Length (in)	<b>N/A</b>
			<b>N/A</b>	DWS Full Width?	<b>N/A</b>
			<b>N/A</b>	DWS Offset (in)	<b>N/A</b>
			<b>N/A</b>	Gutter Slope (%)	<b>N/A</b>
			<b>N/A</b>	Gutter X Slope (%)	<b>N/A</b>
			<b>N/A</b>	Painted X Walk1?	<b>N/A</b>
			<b>N/A</b>	X Walk 1 Direction	<b>N/A</b>
			<b>N/A</b>	X Walk 1 Width (in)	<b>N/A</b>

<b>N/A</b>	X Walk 1 Slope (%)	<b>N/A</b>
			<b>N/A</b>	X Walk 1 X Slope (%)	<b>N/A</b>
			<b>N/A</b>	Ramp inside XWalk1?	<b>N/A</b>
			<b>N/A</b>	Road Slope (%)	<b>N/A</b>
			<b>N/A</b>	Road X Slope (%)	<b>N/A</b>
			<b>N/A</b>	Any Obstructions?	<b>N/A</b>
			<b>N/A</b>	Obstruction Type	<b>N/A</b>
			<b>N/A</b>	Clear Space?	<b>N/A</b>
			<b>N/A</b>	Clear Space to XWalk (in)	<b>N/A</b>
			<b>N/A</b>	Storm Grate/Utility Hazard?	<b>N/A</b>
			<b>N/A</b>	Storm Grate/Utility Type	<b>N/A</b>
			<b>N/A</b>	Surface Condition? (G/P)	<b>Good</b>
