Access Compliance Report Public Rights-of-Way (Curb Ramps)

Intersection ID: 28536 Main Street: SOUTH STREAM BV Cross Street: W TYVOLA RD Location: SW Initial Pass/Fail: Fail **Overall Compliance: No Severity Score:** 22.5 ADA ID: 1E0F5F091A01 Ramp Type: Combination1

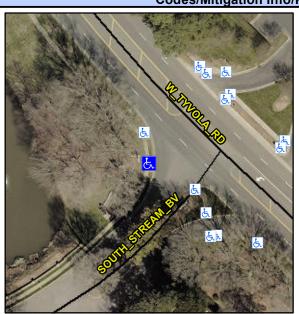
Street 1 Name None **SOUTH STREAM BV** Stop Condition-Street 1 N/A Street 2 Name Stop Condition-Street 2 N/A Possible Solutions: Remove & Replace Entire Ramp. Surveyor Notes: N/A PROW/ADA: Not Found, R304.5.1, R304.5.3, R304.3.2
