# Access Compliance Report

## Public Rights-of-Way

### (Curb Ramps)

| Intersection ID: 50246 | Main Street: DERRYRUSH_DR | Cross Street: HANBERRY_BV | Location: NW |

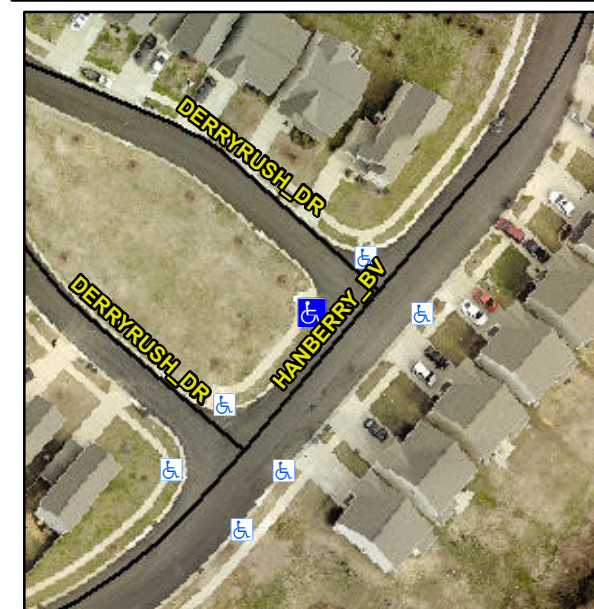
**Not Found, R304.5.1, R304.5.3**

| Compliance | Description | Data | Compliance | Description | Data |
|---|---|---|---|---|---|
| N/A | Ramp Length (in) | 72.0 | Yes | Ramp Slope (%) | 7.3 |
| No | Ramp Width (in) | 41.0 | No | Ramp XSlope (%) | 2.5 |

**Remove & Replace Curb Ramp With Two New Directional Ramps or Equivalent.**
