Access Compliance Report

Public Rights-of-Way

(Curb Ramps)

Intersection ID: N/A	Main Street: LANGWELL_LN	Cross Street: INVERNESS_BAY_RD	Location: NE
ADA ID: 1E18D47C1B3F	Ramp Type: Perp	Initial Pass/Fail: Fail	Overall Compliance: No
Codes/Mitigation Info/Possible Solution		Field Measurements/Component Compliance	
Severity Score: 46.25

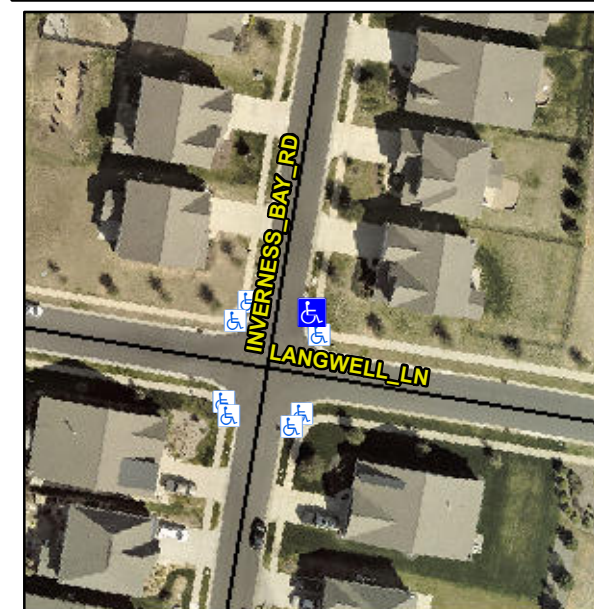
Not Found, R304.5.1, R304.2.2, R304.5.3

Compliance	Description	Data	Compliance	Description	Data
N/A	Ramp Length (in)	47.0	No	Ramp Slope (%)	9.7
No	Ramp Width (in)	47.0	No	Ramp XSlope (%)	7.0
N/A	Flare Type LT	N/A	N/A	Flare Type RT	N/A
N/A	Flare Slope LT (%)	N/A	N/A	Flare Slope RT (%)	N/A
N/A	Flare Traversable LT?	N/A	N/A	Flare Traversable RT?	N/A
N/A	Landing Length (in)	N/A	N/A	DWS Provided?	N/A
N/A	Landing Width (in)	N/A	N/A	DWS Contrast?	N/A
N/A	Landing Slope (%)	N/A	N/A	DWS Length (in)	N/A
N/A	Landing X Slope (%)	N/A	N/A	DWS Full Width?	N/A
N/A	Landing Curb? (Y/N)	N/A	N/A	DWS Offset (in)	N/A
N/A	Shared Landing?	N/A			
N/A	Gutter Ponding?	N/A	N/A	Gutter Slope (%)	N/A
N/A	Gutter Lip Ht (in)	1.0	N/A	Gutter X Slope (%)	N/A
N/A	Painted X Walk1?	No	N/A	Painted X Walk2?	N/A
	X Walk 1 Direction	To NW		X Walk 2 Direction	N/A
N/A	X Walk 1 Width (in)	N/A	N/A	X Walk 2 Width (in)	N/A
	X Walk 1 Slope (%)	1.9		X Walk 2 Slope (%)	N/A
	X Walk 1 X Slope (%)	5.3		X Walk 2 X Slope (%)	N/A

N/A	Ramp inside XWalk1?	N/A	N/A	Ramp inside XWalk2?	N/A
	Road Slope (%)	N/A	N/A	Clear Space?	N/A
	Road X Slope (%)	N/A	N/A	Clear Space to XWalk (in)	N/A
N/A	Any Obstructions?	N/A	N/A	Storm Grate/Utility Hazard?	N/A
	Obstruction Type			Storm Grate/Utility Type	
		N/A			N/A
			Yes	Surface Condition? (G/P)	Good

Possible Solutions:

Remove & Replace Entire Ramp.
