# Access Compliance Report

## Public Rights-of-Way

### (Curb Ramps)

Intersection ID: 14857	Main Street: ATHERTON_ST	Cross Street: SOUTH_BV	Location: E
ADA ID: 1E268F989F49	Ramp Type: Directional1	Initial Pass/Fail: Fail	Overall Compliance: No
			Severity Score: 13.75

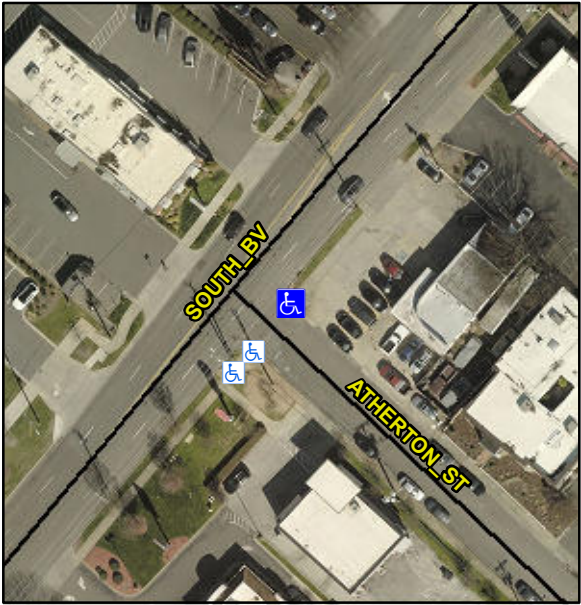
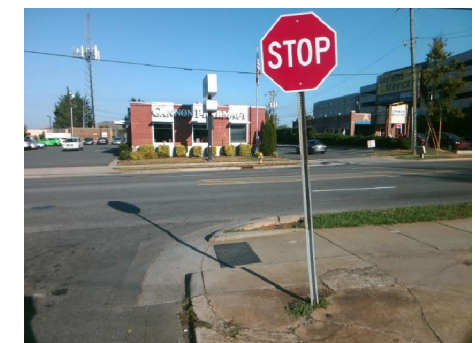
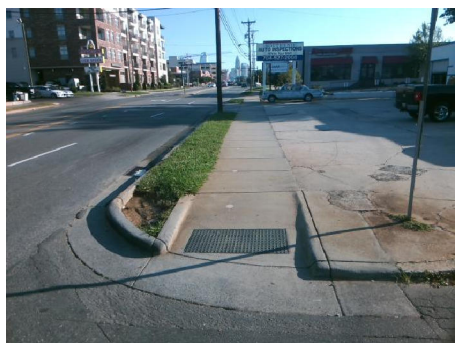
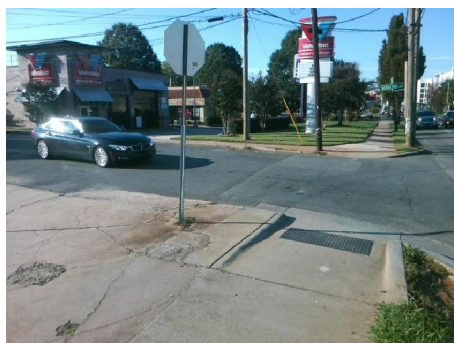
<p>Possible Solutions:</p> <p><b>Remove &amp; Replace Entire Ramp.</b></p> <p>Surveyor Notes:</p> <p><b>N/A</b></p> <p>PROW/ADA:</p> <p><b>R304.2.2, R304.5.3</b></p>		Compliance	Description	Data	Compliance	Description	Data
		N/A	Ramp Length (in)	78.0	N/A	Grade Break?	N/A
		Yes	Ramp Width (in)	64.0	N/A	Grade Break Slope (%)	0.0
		No	Ramp Slope (%)	8.4	N/A	Grade Break XSlope (%)	0.0
		No	Ramp XSlope (%)	2.3			
		N/A	Flare Type LT	N/A	N/A	Flare Type RT	N/A
		N/A	Flare Slope LT (%)	N/A	N/A	Flare Slope RT (%)	0.0
		N/A	Flare Traversable LT?	N/A	N/A	Flare Traversable RT?	N/A
		N/A	Landing Length (in)	0.0	N/A	DWS Provided?	N/A
		N/A	Landing Width (in)	0.0	N/A	DWS Contrast?	N/A
		N/A	Landing Slope (%)	0.0	N/A	DWS Length (in)	N/A
		N/A	Landing X Slope (%)	0.0	N/A	DWS Full Width?	N/A
		N/A	Landing Curb? (Y/N)	N/A	N/A	DWS Offset LT (in)	N/A

N/A	Shared Landing?	N/A	N/A	DWS Offset RT (in)	N/A
		N/A	Gutter Ponding?	0.0	N/A	Gutter Slope (%)	N/A
		N/A	Gutter Lip Ht (in)	0.0	N/A	Gutter X Slope (%)	N/A
		N/A	Painted X Walk1?	No		Road Slope (%)	3.6
			X Walk 1 Direction	To SW		Road X Slope (%)	0.5
			X Walk 1 Width (in)	N/A		Clear Space?	N/A
			X Walk 1 Slope (%)	3.6	N/A	Clear Space to XWalk (in)	N/A
			X Walk 1 X Slope (%)	0.5	N/A	Storm Grate/Utility Hazard?	N/A
		N/A	Ramp inside XWalk1?	N/A		Storm Grate/Utility Type	
		N/A	Any Obstructions?	N/A			N/A
			Obstruction Type		Yes	Surface Condition? (G/P)	Good
					N/A	Curb Slope (%)	3.1
Total Cost:		\$	1600.00
