## **Access Compliance Report Public Rights-of-Way** (Curb Ramps)

Intersection ID: 42729 Main Street: CALDWELL FOREST DR Cross Street: COCHRAN\_RIDGE\_AV Location: NW ADA ID: 1E335783525D Ramp Type: PerpDiag Initial Pass/Fail: Fail **Overall Compliance: No Severity Score:** 10

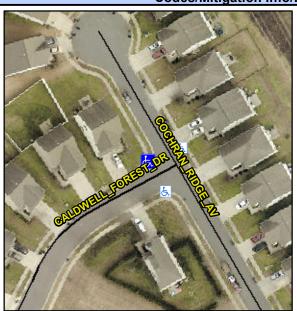
| Field Measurements/Component Compliance | | | | | |
|---|--|---|---|---|---|
| No | Ramp Width (in) | 47.5 | No | Ramp XSlope (%) | 3.1 |

Possible Solutions: Remove & Replace Curb Ramp With **Two New Directional Ramps or** Equivalent. Surveyor Notes: N/A PROW/ADA: Not Found, R304.5.1, R304.5.3
