Access Compliance Report

Public Rights-of-Way

(Curb Ramps)

Intersection ID: 32271	Main Street: SPRINGWELL_ST	Cross Street: SULLIVAN_RIDGE_DR	Location: NE
ADA ID: 1E3801D8CDFB	Ramp Type: PerpDiag	Initial Pass/Fail: Fail	Overall Compliance: No
Severity Score: 21.25			
Codes/Mitigation Info/Possible Solution		Field Measurements/Component Compliance

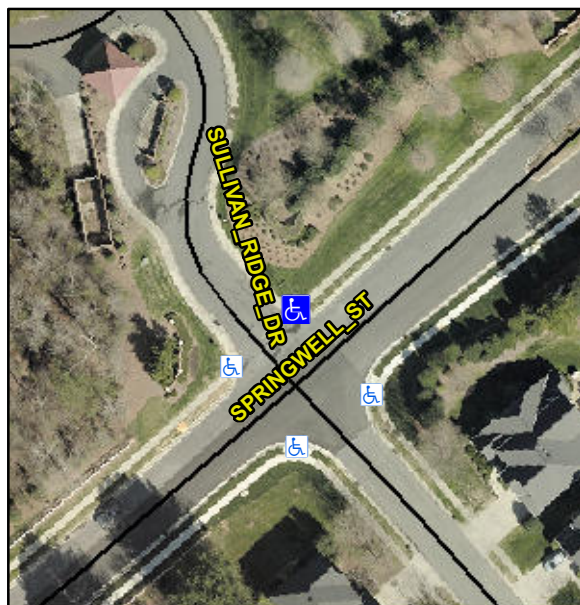
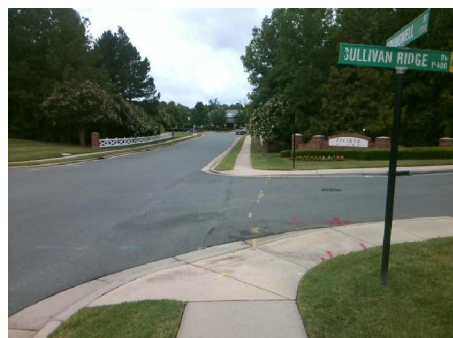
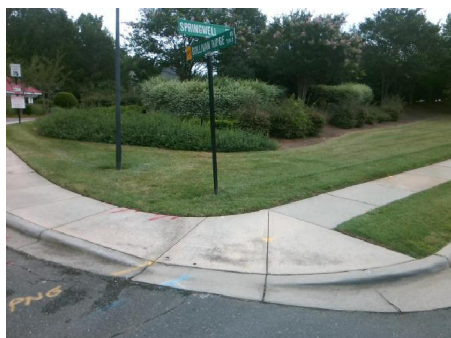
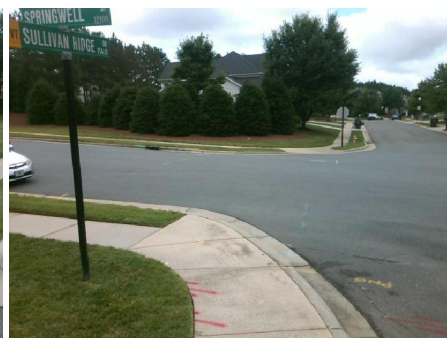
Not Found, R304.5.1, R304.2.2

Compliance	Description	Data	Compliance	Description	Data
N/A	Ramp Length (in)	59.0	No	Ramp Slope (%)	11.9
No	Ramp Width (in)	42.0	Yes	Ramp XSlope (%)	1.7
N/A	Flare Type LT	N/A	N/A	Flare Type RT	N/A
N/A	Flare Slope LT (%)	N/A	N/A	Flare Slope RT (%)	N/A
N/A	Flare Traversable LT?	N/A	N/A	Flare Traversable RT?	N/A
N/A	Landing Length (in)	N/A	N/A	DWS Provided?	N/A
N/A	Landing Width (in)	N/A	N/A	DWS Contrast?	N/A
N/A	Landing Slope (%)	N/A	N/A	DWS Length (in)	N/A
N/A	Landing X Slope (%)	N/A	N/A	DWS Full Width?	N/A
N/A	Landing Curb? (Y/N)	N/A	N/A	DWS Offset (in)	N/A
N/A	Shared Landing?	N/A			
N/A	Gutter Ponding?	N/A	N/A	Gutter Slope (%)	N/A
N/A	Gutter Lip Ht (in)	N/A	N/A	Gutter X Slope (%)	N/A
N/A	Painted X Walk1?	No	N/A	Painted X Walk2?	No
	X Walk 1 Direction	To SW		X Walk 2 Direction	To SE
N/A	X Walk 1 Width (in)	N/A	N/A	X Walk 2 Width (in)	N/A
	X Walk 1 Slope (%)	5.1		X Walk 2 Slope (%)	2.1
	X Walk 1 X Slope (%)	0.5		X Walk 2 X Slope (%)	5.6

N/A	Ramp inside XWalk1?	N/A	N/A	Ramp inside XWalk2?	N/A
	Road Slope (%)	2.3	N/A	Clear Space?	N/A
	Road X Slope (%)	6.0	N/A	Clear Space to XWalk (in)	N/A
N/A	Any Obstructions?	N/A	N/A	Storm Grate/Utility Hazard?	N/A
	Obstruction Type			Storm Grate/Utility Type	
		N/A			N/A
		Yes		Surface Condition? (G/P)	Good

Possible Solutions:

Remove & Replace Curb Ramp With Two New Directional Ramps or Equivalent.
