Access Compliance Report Public Rights-of-Way (Curb Ramps)

Intersection ID: 46179	ID: 46179 Main Street: SEVEN_OAKS_DR			Street:	ROCKY_RIVER_RD	Location:	NW		
ADA ID: 1E3CFFD5A60C	A60C Ramp Type: PerpDiag		Initial Pass/Fail: Fail Overall Compliance: No				o Severity Score:	8.75	
Codes/Mitigation Info/Possible Solution				Field Measurements/Component Compliance					
		Possible Solutions:		Compliance Description			Data Compliance Description

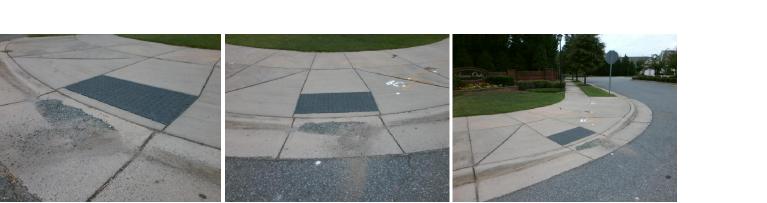
G.		Remove & Replace Curb Ramp V	Vith	N/A	Ramp Length (in)	71.5	1	Ramp Slope (%)	7.7
the log of		Two New Directional Ramps or	VILII	No	Ramp Width (in)	37.5		Ramp XSlope (%)	1.9
		Equivalent.		N/A	Flare Type LT	N/A		Flare Type RT	N/A
No.				N/A	Flare Slope LT (%)		N/A	Flare Slope RT (%)	N/A
ALL				N/A	Flare Traversable LT?	N/A		Flare Traversable RT?	N/A
The start of the second		1		N/A	Landing Length (in)	N/A		DWS Provided?	N/A
A Company of the second s		Surveyor Notes:		N/A	Landing Width (in)	N/A	N/A	DWS Contrast?	N/A
				N/A	,	N/A			N/A N/A
		N/A			Landing Slope (%)			DWS Length (in)	
AN COM Y	Real Contractions			N/A	Landing X Slope (%)	N/A	N/A	DWS Full Width?	N/A

C. M.			N/A	Landing Curb? (Y/N)	N/A	N/A	DWS Offset (in)	N/A
CO SAL	<u>a.a.</u>			N/A	Shared Landing?	N/A			
	Kus 1	PROW/ADA:		N/A	Gutter Ponding?	Yes	N/A	Gutter Slope (%)	N/A
	Not Found, R304.5.1		N/A	Gutter Lip Ht (in)	N/A	N/A	Gutter X Slope (%)	N/A	
				N/A	Painted X Walk1?	No	N/A	Painted X Walk2?	No
					X Walk 1 Direction	To E		X Walk 2 Direction	To SE
				N/A	X Walk 1 Width (in)	N/A	N/A	X Walk 2 Width (in)	N/A
Street 1 Name	SEVEN OAKS DR				X Walk 1 Slope (%)	2.2		X Walk 2 Slope (%)	0.7
Stop Condition-Street 2	None				X Walk 1 X Slope (%)	2.2		X Walk 2 X Slope (%)	1.7
Street 2 Name	ROCKY RIVER RD			N/A	Ramp inside XWalk1?	N/A	N/A	Ramp inside XWalk2?	N/A
Stop Condition-Street 1	StopSign				Road Slope (%)	0.6	N/A	Clear Space?	N/A
	. •				Road X Slope (%)	2.4	N/A	Clear Space to XWalk (in)	N/A
				N/A	Any Obstructions?	N/A		Storm Grate/Utility Hazard?	N/A
		Total Cost: \$ 3	200.00		Obstruction Type			Storm Grate/Utility Type
