Access Compliance Report

Public Rights-of-Way (Curb Ramps)

Intersection ID: 4118	Main Street: DAVID_COX_RD	Cross Street: OLD_SUGAR_CREEK_RD	Location: SE
ADA ID: 1E445094DC47	Ramp Type: Perp	Initial Pass/Fail: Fail	Overall Compliance: No
Severity Score: 12.5			
Codes/Mitigation Info/Possible Solution		Field Measurements/Component Compliance

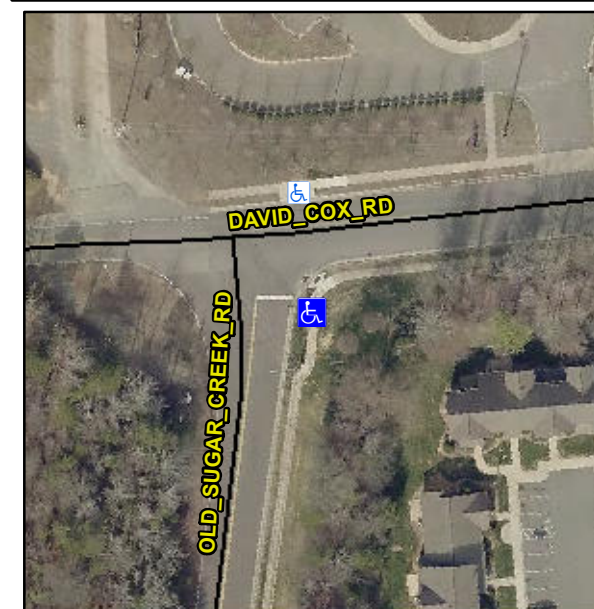
R304.2.2

Compliance	Description	Data	Compliance	Description	Data
N/A	Ramp Length (in)	48.0	No	Ramp Slope (%)	10.0
Yes	Ramp Width (in)	48.0	Yes	Ramp XSlope (%)	0.1
N/A	Flare Type LT	N/A	N/A	Flare Type RT	N/A
N/A	Flare Slope LT (%)	N/A	N/A	Flare Slope RT (%)	N/A
N/A	Flare Traversable LT?	N/A	N/A	Flare Traversable RT?	N/A
N/A	Landing Length (in)	N/A	N/A	DWS Provided?	N/A
N/A	Landing Width (in)	N/A	N/A	DWS Contrast?	N/A
N/A	Landing Slope (%)	N/A	N/A	DWS Length (in)	N/A
N/A	Landing X Slope (%)	N/A	N/A	DWS Full Width?	N/A
N/A	Landing Curb? (Y/N)	N/A	N/A	DWS Offset (in)	N/A
N/A	Shared Landing?	N/A			
N/A	Gutter Ponding?	N/A	N/A	Gutter Slope (%)	N/A
N/A	Gutter Lip Ht (in)	N/A	N/A	Gutter X Slope (%)	N/A
N/A	Painted X Walk1?	No	N/A	Painted X Walk2?	N/A
	X Walk 1 Direction	To N		X Walk 2 Direction	N/A
N/A	X Walk 1 Width (in)	N/A	N/A	X Walk 2 Width (in)	N/A
	X Walk 1 Slope (%)	4.3		X Walk 2 Slope (%)	N/A
	X Walk 1 X Slope (%)	1.8		X Walk 2 X Slope (%)	N/A

N/A	Ramp inside XWalk1?	N/A	N/A	Ramp inside XWalk2?	N/A
	Road Slope (%)	N/A	N/A	Clear Space?	N/A
	Road X Slope (%)	N/A	N/A	Clear Space to XWalk (in)	N/A
N/A	Any Obstructions?	N/A	N/A	Storm Grate/Utility Hazard?	N/A
	Obstruction Type			Storm Grate/Utility Type	
		N/A			N/A
			Yes	Surface Condition? (G/P)	Good

Remove & Replace Entire Ramp.

\$ 1850.00
