Access Compliance Report

Public Rights-of-Way

(Curb Ramps)

Intersection ID: 10471	Main Street: CALLAHAN_ST	Cross Street: STATESVILLE_AV	Location: SW
ADA ID: 1E47DDAE11D2	Ramp Type: PerpDiag	Initial Pass/Fail: Fail	Overall Compliance: No
		Severity Score: 10

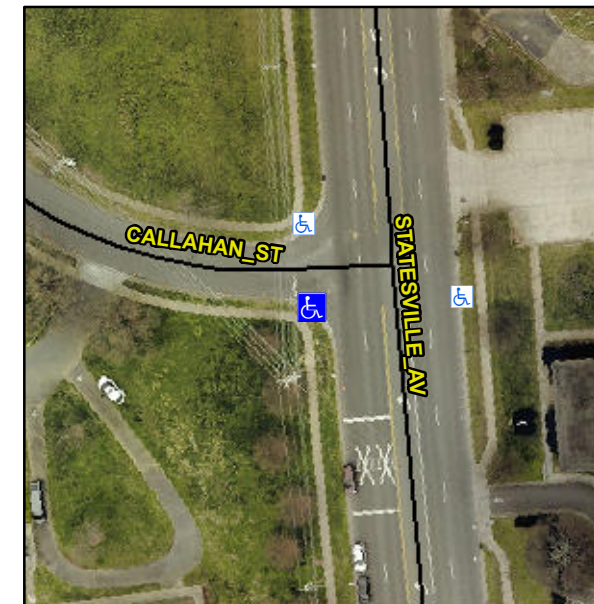
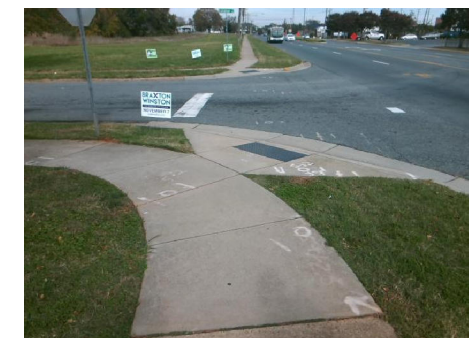
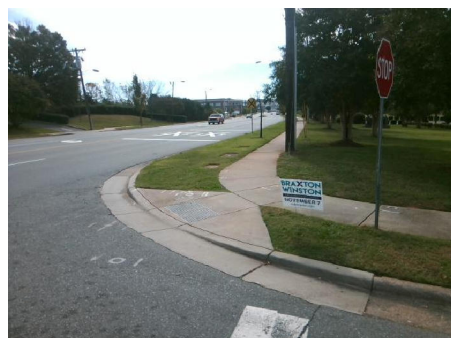
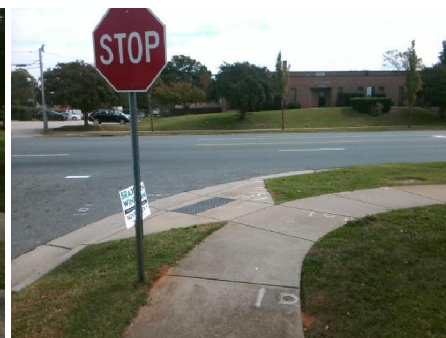
Not Found, R304.5.1, R304.5.3

Compliance	Description	Data	Compliance	Description	Data
N/A	Ramp Length (in)	60.0	Yes	Ramp Slope (%)	5.5
No	Ramp Width (in)	47.0	No	Ramp XSlope (%)	2.4
N/A	Flare Type LT	N/A	N/A	Flare Type RT	N/A
N/A	Flare Slope LT (%)	N/A	N/A	Flare Slope RT (%)	N/A
N/A	Flare Traversable LT?	N/A	N/A	Flare Traversable RT?	N/A
N/A	Landing Length (in)	N/A	N/A	DWS Provided?	N/A
N/A	Landing Width (in)	N/A	N/A	DWS Contrast?	N/A
N/A	Landing Slope (%)	N/A	N/A	DWS Length (in)	N/A
N/A	Landing X Slope (%)	N/A	N/A	DWS Full Width?	N/A
N/A	Landing Curb? (Y/N)	N/A	N/A	DWS Offset (in)	N/A
N/A	Shared Landing?	N/A			
N/A	Gutter Ponding?	N/A	N/A	Gutter Slope (%)	N/A
N/A	Gutter Lip Ht (in)	N/A	N/A	Gutter X Slope (%)	N/A
N/A	Painted X Walk1?	No	N/A	Painted X Walk2?	No
	X Walk 1 Direction	To E		X Walk 2 Direction	To N
N/A	X Walk 1 Width (in)	N/A	N/A	X Walk 2 Width (in)	N/A
	X Walk 1 Slope (%)	0.7		X Walk 2 Slope (%)	0.7
	X Walk 1 X Slope (%)	1.0		X Walk 2 X Slope (%)	0.8

N/A	Ramp inside XWalk1?	N/A	N/A	Ramp inside XWalk2?	N/A
	Road Slope (%)	0.4	N/A	Clear Space?	N/A
	Road X Slope (%)	2.7	N/A	Clear Space to XWalk (in)	N/A
N/A	Any Obstructions?	N/A	N/A	Storm Grate/Utility Hazard?	N/A
	Obstruction Type			Storm Grate/Utility Type	
		N/A			N/A
			Yes	Surface Condition? (G/P)	Good

Remove & Replace Curb Ramp With Two New Directional Ramps or Equivalent.

Total Cost: \$ 3200.00
