Access Compliance Report Public Rights-of-Way (Curb Ramps)

Intersection ID: 9396 Main Street: MORETZ_AV Cross Street: N_GRAHAM_ST Location: E

ADA ID: 1E518D35A992 Ramp Type: Perp Initial Pass/Fail: Fail Overall Compliance: No Severity Score: 26.25

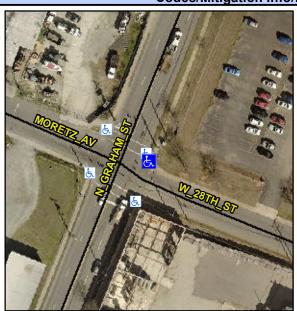
Field Measurements/Component Compliance							
Comp	liance Description	Data	Comp	liance	Description	Data	
N/A	Ramp Length (in)	55.0	No	Ramp	Slope (%)	13.4	
Yes	Ramp Width (in)	52.0	No	Ramp	XSlope (%)	4.5	
N/A	Flare Type LT	N/A	N/A	Flare	Type RT	N/A	
N/A	Flare Slope LT (%)	N/A	N/A	Flare	Slope RT (%)	N/A	
N/A	Flare Traversable LT?	N/A	N/A	Flare	Traversable RT?	N/A	
N/A	Landing Length (in)	N/A	N/A	DWS	Provided?	N/A	
N/A	Landing Width (in)	N/A	N/A	DWS	Contrast?	N/A	
N/A	Landing Slope (%)	N/A	N/A	DWS	Length (in)	N/A	
N/A	Landing X Slope (%)	N/A	N/A	DWS	Full Width?	N/A	
N/A	Landing Curb? (Y/N)	N/A	N/A	DWS	Offset (in)	N/A	
N/A	Shared Landing?	N/A					
N/A	Gutter Ponding?	N/A	N/A	Gutte	r Slope (%)	N/A	
N/A	Gutter Lip Ht (in)	2.0	N/A	Gutte	r X Slope (%)	N/A	
N/A	Painted X Walk1?	Yes	N/A	Painte	ed X Walk2?	N/A	
	X Walk 1 Direction	To SW		X Wa	lk 2 Direction	N/A	
N/A	X Walk 1 Width (in)	113.5	N/A	X Wa	lk 2 Width (in)	N/A

X Walk 1 Slope (%)	0.8		X Wa	lk 2 Slope (%)	N/A	
	X Walk 1 X Slope (%)	3.4		X Wa	lk 2 X Slope (%)	N/A	
N/A	Ramp inside XWalk1?	Yes	N/A	Ramp	inside XWalk2?	N/A	
	Road Slope (%)	N/A	N/A	Clear	Space?	N/A	
	Road X Slope (%)	N/A	N/A	Clear	Space to XWalk (in)	N/A	
N/A	Any Obstructions?	N/A	N/A	Storm	Grate/Utility Hazard?	N/A	
	Obstruction Type			Storm	Grate/Utility Type		
		N/A				N/A	
			Yes	Surfa	ce Condition? (G/P)	Good

CCCIDIC CCIALICIT	
Possible Solutions:	Cor
Remove & Replace Entire Ramp.	N/A
·	Yes
	N/A
	N/A
	N/A
	N/A
Surveyor Notes:	N/A
N/A	N/A
	N/A
	N/A
	N/A
PROW/ADA:	N/A
R304.2.2, R304.5.3	N/A
	N/A
	N/A
	N/A

1850.00
