Access Compliance Report

Public Rights-of-Way

(Curb Ramps)

Intersection ID: 48948	Main Street: BIRCHLEY_CR	Cross Street: DAVID_JENNINGS_AV	Location:	N
ADA ID: 1E5AB1B1C835	Ramp Type: Combination2	Initial Pass/Fail: Fail	Overall Compliance: No	Severity Score: 10

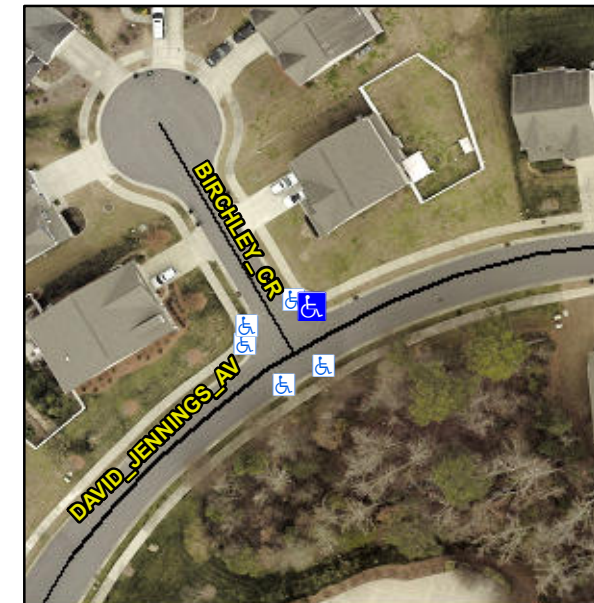
RT RP < 5%

Not Found, R304.5.1, R304.5.3

Compliance	Description	Data	Compliance	Description	Data
N/A	Ramp Length LT (in)	2.0	N/A	Ramp Length RT (in)	11.5
Yes	Ramp Width LT (in)	59.0	N/A	Ramp Width RT (in)	58.0
Yes	Ramp Slope LT (%)	6.9	N/A	Ramp Slope RT (%)	4.5
Yes	Ramp XSlope LT (%)	1.4	N/A	Ramp XSlope RT (%)	2.8
N/A	Ramp Length (in)	47.5	Yes	Ramp Slope (%)	2.8
No	Ramp Width (in)	46.0	No	Ramp XSlope (%)	4.5
N/A	Flare Type LT	N/A	N/A	Flare Type RT	N/A
N/A	Flare Slope LT (%)	N/A	N/A	Flare Slope RT (%)	N/A
N/A	Flare Traversable LT?	N/A	N/A	Flare Traversable RT?	N/A
N/A	Landing Length (in)	N/A	N/A	DWS Provided?	N/A
N/A	Landing Width (in)	N/A	N/A	DWS Contrast?	N/A
N/A	Landing Slope (%)	N/A	N/A	DWS Length (in)	N/A
N/A	Landing X Slope (%)	N/A	N/A	DWS Full Width?	N/A
N/A	Landing Curb? (Y/N)	N/A	N/A	DWS Offset (in)	N/A
N/A	Shared Landing?	N/A			
N/A	Gutter Ponding?	N/A	N/A	Gutter Slope (%)	N/A
N/A	Gutter Lip Ht (in)	N/A	N/A	Gutter X Slope (%)	N/A
N/A	Painted X Walk1?	No	N/A	Painted X Walk2?	N/A

X Walk 1 Direction	To NE		X Walk 2 Direction	N/A
	X Walk 1 Width (in)	N/A		X Walk 2 Width (in)	N/A
	X Walk 1 Slope (%)	1.6		X Walk 2 Slope (%)	N/A
	X Walk 1 X Slope (%)	3.1		X Walk 2 X Slope (%)	N/A
N/A	Ramp inside XWalk1?	N/A	N/A	Ramp inside XWalk2?	N/A
	Road Slope (%)	N/A		Clear Space?	N/A
	Road X Slope (%)	N/A	N/A	Clear Space to XWalk (in)	N/A
			N/A	Any Obstruction?	N/A
				Obstruction Type	N/A
			N/A	Storm Grate/Utility Hazard?	N/A
				Storm Grate/Utility Type	N/A
			Yes	Surface Condition? (G/P)	Good
				Curb Slope (%)	31.5

Remove & Replace Entire Ramp.
