Access Compliance Report

Public Rights-of-Way

(Curb Ramps)

Intersection ID: 15094	Main Street: ALBEMARLE_RD	Cross Street: REDDMAN_RD	Location: NE
ADA ID: 1E601451CD7A	Ramp Type: Perp	Initial Pass/Fail: Fail	Overall Compliance: No
Severity Score: 33.75			
Codes/Mitigation Info/Possible Solution		Field Measurements/Component Compliance

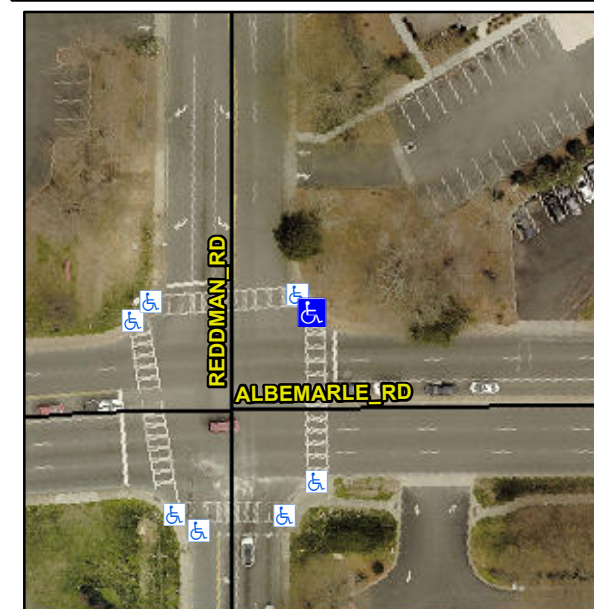
Not Found, R304.5.1, R304.2.2, R304.5.3

Compliance	Description	Data	Compliance	Description	Data
N/A	Ramp Length (in)	60.0	No	Ramp Slope (%)	9.7
No	Ramp Width (in)	41.0	No	Ramp XSlope (%)	6.9
N/A	Flare Type LT	N/A	N/A	Flare Type RT	N/A
N/A	Flare Slope LT (%)	N/A	N/A	Flare Slope RT (%)	N/A
N/A	Flare Traversable LT?	N/A	N/A	Flare Traversable RT?	N/A
N/A	Landing Length (in)	N/A	N/A	DWS Provided?	N/A
N/A	Landing Width (in)	N/A	N/A	DWS Contrast?	N/A
N/A	Landing Slope (%)	N/A	N/A	DWS Length (in)	N/A
N/A	Landing X Slope (%)	N/A	N/A	DWS Full Width?	N/A
N/A	Landing Curb? (Y/N)	N/A	N/A	DWS Offset (in)	N/A
N/A	Shared Landing?	N/A			
N/A	Gutter Ponding?	N/A	N/A	Gutter Slope (%)	N/A
N/A	Gutter Lip Ht (in)	N/A	N/A	Gutter X Slope (%)	N/A
N/A	Painted X Walk1?	Yes	N/A	Painted X Walk2?	N/A
	X Walk 1 Direction	To S		X Walk 2 Direction	N/A
N/A	X Walk 1 Width (in)	110.0	N/A	X Walk 2 Width (in)	N/A
	X Walk 1 Slope (%)	2.8		X Walk 2 Slope (%)	N/A
	X Walk 1 X Slope (%)	4.5		X Walk 2 X Slope (%)	N/A

N/A	Ramp inside XWalk1?	Yes	N/A	Ramp inside XWalk2?	N/A
	Road Slope (%)	N/A	N/A	Clear Space?	N/A
	Road X Slope (%)	N/A	N/A	Clear Space to XWalk (in)	N/A
N/A	Any Obstructions?	N/A	N/A	Storm Grate/Utility Hazard?	N/A
	Obstruction Type			Storm Grate/Utility Type	
		N/A			N/A
		Yes		Surface Condition? (G/P)	Good

Possible Solutions:

Remove & Replace Entire Ramp.
