Access Compliance Report Public Rights-of-Way (Curb Ramps)

Intersection ID: 12818 Main Street: SCHOOL_ST Cross Street: SCHOOL_ST Location: SW

ADA ID: 1E6188564BB2 Ramp Type: Perp Initial Pass/Fail: Fail Overall Compliance: No Severity Score: 13.75

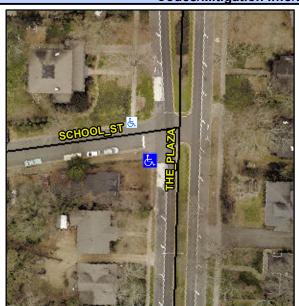
Com	oliance Description	Data	Comp	liance Description	Data
N/A	Ramp Length (in)	61.0	No	Ramp Slope (%)	8.9
Yes	Ramp Width (in)	48.0	No	Ramp XSlope (%)	3.6
N/A	Flare Type LT	N/A	N/A	Flare Type RT	N/A
N/A	Flare Slope LT (%)	N/A	N/A	Flare Slope RT (%)	N/A
N/A	Flare Traversable LT?	N/A	N/A	Flare Traversable RT?	N/A
N/A	Landing Length (in)	N/A	N/A	DWS Provided?	N/A
N/A	Landing Width (in)	N/A	N/A	DWS Contrast?	N/A
N/A	Landing Slope (%)	N/A	N/A	DWS Length (in)	N/A
N/A	Landing X Slope (%)	N/A	N/A	DWS Full Width?	N/A
N/A	Landing Curb? (Y/N)	N/A	N/A	DWS Offset (in)	N/A
N/A	Shared Landing?	N/A			
N/A	Gutter Ponding?	N/A	N/A	Gutter Slope (%)	N/A
N/A	Gutter Lip Ht (in)	N/A	N/A	Gutter X Slope (%)	N/A
N/A	Painted X Walk1?	No	N/A	Painted X Walk2?	N/A
	X Walk 1 Direction	To NW		X Walk 2 Direction	N/A
N/A	X Walk 1 Width (in)	N/A	N/A	X Walk 2 Width (in)	N/A
	X Walk 1 Slope (%)	0.2		X Walk 2 Slope (%)	N/A
	X Walk 1 X Slope (%)	5.4		X Walk 2 X Slope (%)	N/A

T CCCIDIC CCIALICIT	
Possible Solutions:	<u>C</u>
Remove & Replace Entire Ramp.	N
·	Y
	N
	N
	N
	N
Surveyor Notes:	N
N/A	N
	N
	N
	N
PROW/ADA:	N
R304.2.2, R304.5.3	N
	N
	N

1850.00
