Access Compliance Report

Public Rights-of-Way

(Curb Ramps)

Intersection ID: 10370	Main Street: SOLOMON_ST	Cross Street: W_TRADE_ST	Location:	N
ADA ID: 1E64C26CEA94	Ramp Type: Perp	Initial Pass/Fail: Fail	Overall Compliance: No	Severity Score: 22.5
Codes/Mitigation Info/Possible Solution		Field Measurements/Component Compliance

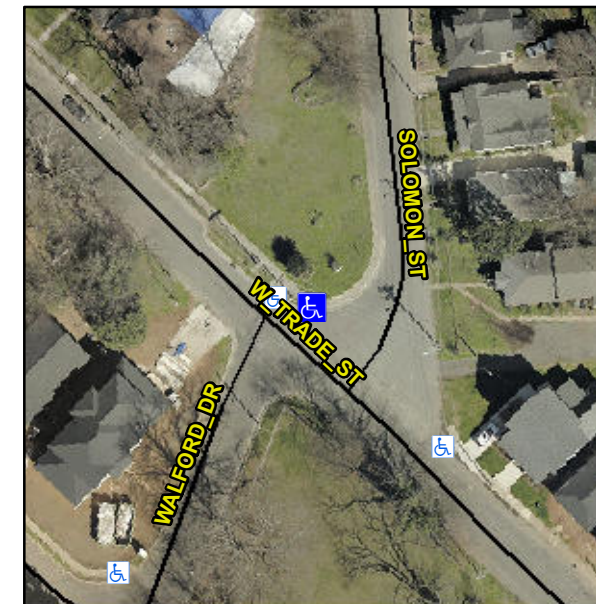
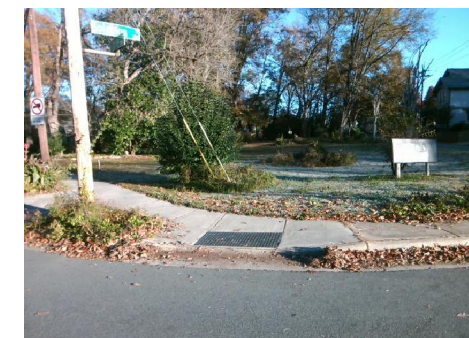
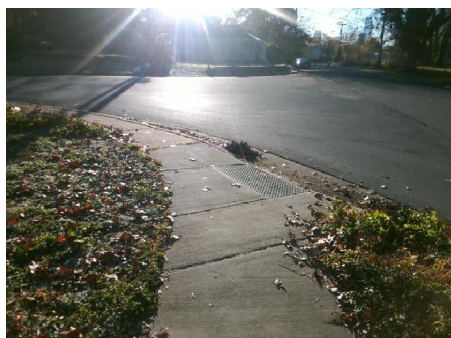
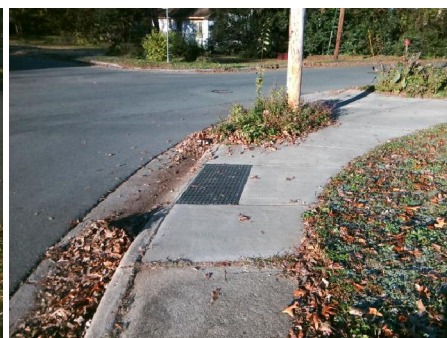
Not Found, R304.5.1, R304.2.2, R304.5.3

Compliance	Description	Data	Compliance	Description	Data
N/A	Ramp Length (in)	56.0	No	Ramp Slope (%)	8.8
No	Ramp Width (in)	46.0	No	Ramp XSlope (%)	3.0
N/A	Flare Type LT	N/A	N/A	Flare Type RT	N/A
N/A	Flare Slope LT (%)	N/A	N/A	Flare Slope RT (%)	N/A
N/A	Flare Traversable LT?	N/A	N/A	Flare Traversable RT?	N/A
N/A	Landing Length (in)	N/A	N/A	DWS Provided?	N/A
N/A	Landing Width (in)	N/A	N/A	DWS Contrast?	N/A
N/A	Landing Slope (%)	N/A	N/A	DWS Length (in)	N/A
N/A	Landing X Slope (%)	N/A	N/A	DWS Full Width?	N/A
N/A	Landing Curb? (Y/N)	N/A	N/A	DWS Offset (in)	N/A
N/A	Shared Landing?	N/A			
N/A	Gutter Ponding?	N/A	N/A	Gutter Slope (%)	N/A
N/A	Gutter Lip Ht (in)	0.5	N/A	Gutter X Slope (%)	N/A
N/A	Painted X Walk1?	No	N/A	Painted X Walk2?	N/A
	X Walk 1 Direction	To SE		X Walk 2 Direction	N/A
N/A	X Walk 1 Width (in)	N/A	N/A	X Walk 2 Width (in)	N/A
	X Walk 1 Slope (%)	0.8		X Walk 2 Slope (%)	N/A
	X Walk 1 X Slope (%)	3.1		X Walk 2 X Slope (%)	N/A

N/A	Ramp inside XWalk1?	N/A	N/A	Ramp inside XWalk2?	N/A
	Road Slope (%)	N/A	N/A	Clear Space?	N/A
	Road X Slope (%)	N/A	N/A	Clear Space to XWalk (in)	N/A
N/A	Any Obstructions?	N/A	N/A	Storm Grate/Utility Hazard?	N/A
	Obstruction Type			Storm Grate/Utility Type	
		N/A			N/A
			Yes	Surface Condition? (G/P)	Good

Possible Solutions:

Remove & Replace Entire Ramp.
