# Access Compliance Report

## Public Rights-of-Way

### (Curb Ramps)

| Intersection ID: 24792 | Main Street: ASHERTON_DR | Cross Street: CARMEL_RD | Location: NW |

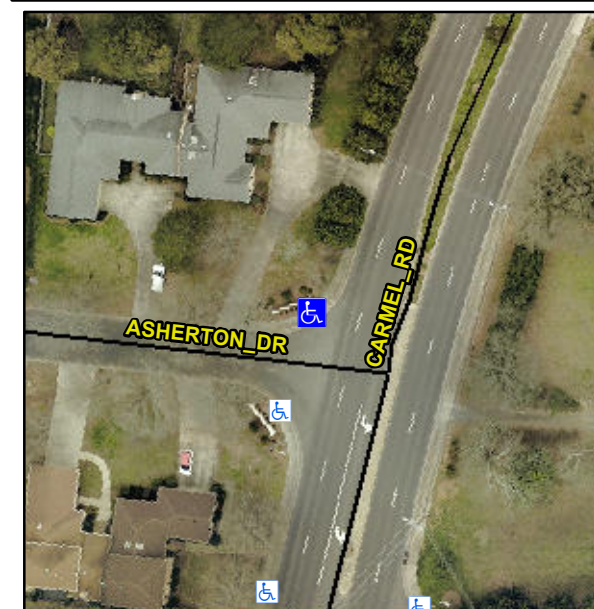
| ADA ID: 1E771B227A8A | Ramp Type: PerpDiag | Initial Pass/Fail: Fail | Overall Compliance: No |

**Not Found, R304.5.1, R304.2.2, R304.5.3**

| Compliance | Description | Data | Compliance | Description | Data |
|---|---|---|---|---|---|
| N/A | Ramp Length (in) | 60.0 | No | Ramp Slope (%) | 10.5 |
| No | Ramp Width (in) | 42.0 | No | Ramp XSlope (%) | 3.0 |

**Remove & Replace Curb Ramp With Two New Directional Ramps or Equivalent.**

Total Cost: \$ 3200.00
