Access Compliance Report

Public Rights-of-Way

(Curb Ramps)

Intersection ID: N/A	Main Street: SUMMERFIELD RIDGE LN	Cross Street: SUMMERGROVE CT	Location: NW
ADA ID: 1E7E101DB9A6	Ramp Type: PerpDiag	Initial Pass/Fail: Fail	Overall Compliance: No
		Severity Score: 8.75

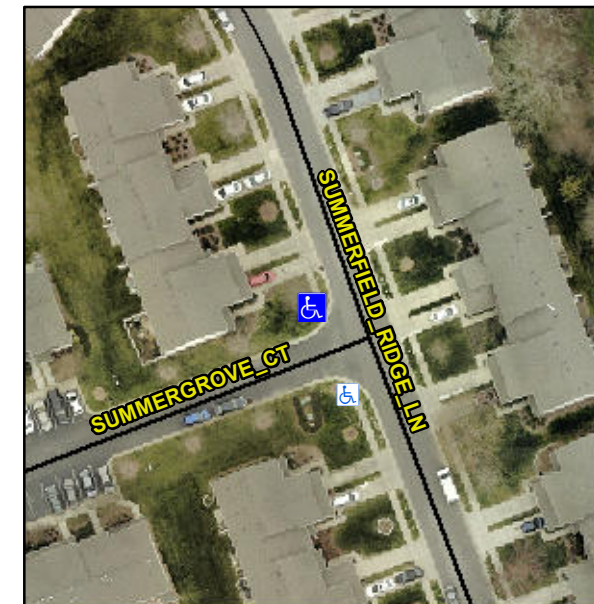
Not Found, R304.5.1

Compliance	Description	Data	Compliance	Description	Data
N/A	Ramp Length (in)	48.0	Yes	Ramp Slope (%)	7.2
No	Ramp Width (in)	39.0	Yes	Ramp XSlope (%)	1.9
N/A	Flare Type LT	N/A	N/A	Flare Type RT	N/A
N/A	Flare Slope LT (%)	N/A	N/A	Flare Slope RT (%)	N/A
N/A	Flare Traversable LT?	No	N/A	Flare Traversable RT?	No
N/A	Landing Length (in)	N/A	N/A	DWS Provided?	N/A
N/A	Landing Width (in)	N/A	N/A	DWS Contrast?	N/A
N/A	Landing Slope (%)	N/A	N/A	DWS Length (in)	N/A
N/A	Landing X Slope (%)	N/A	N/A	DWS Full Width?	N/A
N/A	Landing Curb? (Y/N)	N/A	N/A	DWS Offset (in)	N/A
N/A	Shared Landing?	N/A			
N/A	Gutter Ponding?	N/A	N/A	Gutter Slope (%)	N/A
N/A	Gutter Lip Ht (in)	N/A	N/A	Gutter X Slope (%)	N/A
N/A	Painted X Walk1?	No	N/A	Painted X Walk2?	Yes
	X Walk 1 Direction	To S		X Walk 2 Direction	To E
N/A	X Walk 1 Width (in)	N/A	N/A	X Walk 2 Width (in)	N/A
	X Walk 1 Slope (%)	2.5		X Walk 2 Slope (%)	1.8
	X Walk 1 X Slope (%)	2.1		X Walk 2 X Slope (%)	1.2

N/A	Ramp inside XWalk1?	N/A	N/A	Ramp inside XWalk2?	N/A
	Road Slope (%)	1.7	N/A	Clear Space?	N/A
	Road X Slope (%)	0.8	N/A	Clear Space to XWalk (in)	N/A
N/A	Any Obstructions?	N/A	N/A	Storm Grate/Utility Hazard?	N/A
	Obstruction Type			Storm Grate/Utility Type	
		N/A			N/A
			Yes	Surface Condition? (G/P)	Good

Remove & Replace Curb Ramp With Two New Directional Ramps or Equivalent.

Total Cost: \$ 3200.00
