# Access Compliance Report

## Public Rights-of-Way

### (Curb Ramps)

Intersection ID: 9129	Main Street: N_GRAHAM_ST	Cross Street: NORRIS_AV	Location: N
ADA ID: 1E7FA34ADEA0	Ramp Type: Perp	Initial Pass/Fail: Fail	Overall Compliance: No
			Severity Score: 21.25

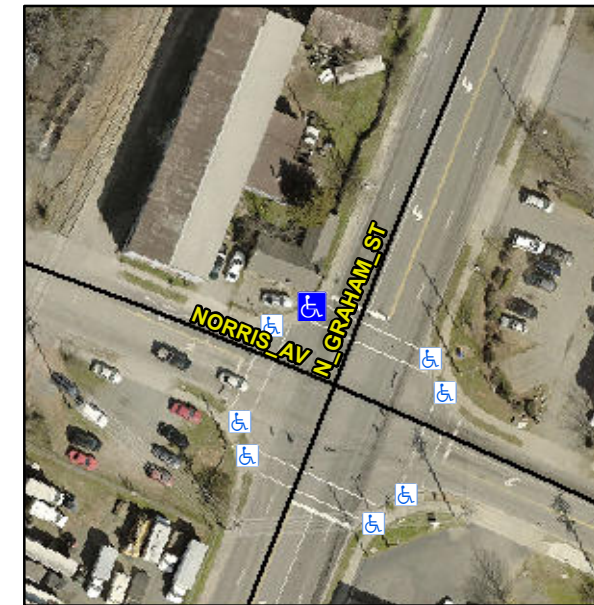
**Not Found, R304.5.1, R304.5.3**

Compliance	Description	Data	Compliance	Description	Data
N/A	Ramp Length (in)	59.5	Yes	Ramp Slope (%)	7.9
No	Ramp Width (in)	45.0	No	Ramp XSlope (%)	5.2
N/A	Flare Type LT	N/A	N/A	Flare Type RT	N/A
N/A	Flare Slope LT (%)	N/A	N/A	Flare Slope RT (%)	N/A
N/A	Flare Traversable LT?	N/A	N/A	Flare Traversable RT?	N/A
N/A	Landing Length (in)	N/A	N/A	DWS Provided?	N/A
N/A	Landing Width (in)	N/A	N/A	DWS Contrast?	N/A
N/A	Landing Slope (%)	N/A	N/A	DWS Length (in)	N/A
N/A	Landing X Slope (%)	N/A	N/A	DWS Full Width?	N/A
N/A	Landing Curb? (Y/N)	N/A	N/A	DWS Offset (in)	N/A
N/A	Shared Landing?	N/A			
N/A	Gutter Ponding?	N/A	N/A	Gutter Slope (%)	N/A
N/A	Gutter Lip Ht (in)	N/A	N/A	Gutter X Slope (%)	N/A
N/A	Painted X Walk1?	Yes	N/A	Painted X Walk2?	N/A
	X Walk 1 Direction	To SE		X Walk 2 Direction	N/A
N/A	X Walk 1 Width (in)	118.0	N/A	X Walk 2 Width (in)	N/A
	X Walk 1 Slope (%)	0.3		X Walk 2 Slope (%)	N/A
	X Walk 1 X Slope (%)	0.1		X Walk 2 X Slope (%)	N/A

N/A	Ramp inside XWalk1?	Yes	N/A	Ramp inside XWalk2?	N/A
	Road Slope (%)	N/A	N/A	Clear Space?	N/A
	Road X Slope (%)	N/A	N/A	Clear Space to XWalk (in)	N/A
N/A	Any Obstructions?	N/A	N/A	Storm Grate/Utility Hazard?	N/A
	Obstruction Type			Storm Grate/Utility Type	
		N/A			N/A
			Yes	Surface Condition? (G/P)	Good

Possible Solutions:

**Remove & Replace Entire Ramp.**
