# Access Compliance Report

## Public Rights-of-Way (Curb Ramps)

Intersection ID: 31180	Main Street: SPRING_PARK_DR	Cross Street: BARBEE_DR	Location: SW
ADA ID: 1E8C7B128AB5	Ramp Type: BlendTrans1	Initial Pass/Fail: Fail	Overall Compliance: No
		Severity Score: 10

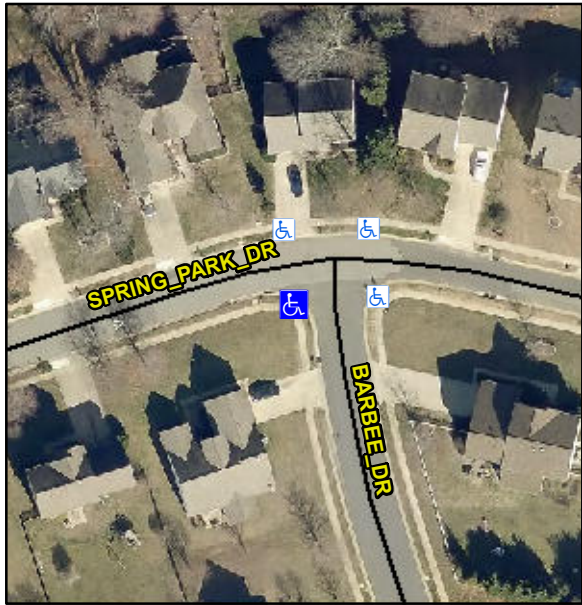
N/A	Landing X Slope (%)	N/A	N/A	DWS Full Width?	N/A			
<div>Surveyor Notes:</div> <div>N/A</div> <div>PROW/ADA:</div> <div>R304.5.1, R304.5.3</div>	N/A	Landing Curb? (Y/N)	N/A	N/A	DWS Offset (in)	N/A			
	N/A	Shared Landing?	N/A						
	N/A	Gutter Ponding?	N/A	N/A	Gutter Slope (%)	N/A			
	N/A	Gutter Lip Ht (in)	N/A	N/A	Gutter X Slope (%)	N/A			
	N/A	Painted X Walk1?	No	N/A	Painted X Walk2?	No			
		X Walk 1 Direction	To E		X Walk 2 Direction	To N			
		X Walk 1 Width (in)	N/A		X Walk 2 Width (in)	N/A			
		X Walk 1 Slope (%)	2.7		X Walk 2 Slope (%)	1.0			
		X Walk 1 X Slope (%)	0.9		X Walk 2 X Slope (%)	1.5			
	N/A	Ramp inside XWalk1?	N/A	N/A	Ramp inside XWalk2?	N/A			
<div>Total Cost:</div> <div>\$3200.00</div>		Road Slope (%)	0.9		Clear Space?	N/A			
		Road X Slope (%)	1.9	N/A	Clear Space to XWalk (in)	N/A			
	N/A	Any Obstructions?	N/A	N/A	Storm Grate/Utility Hazard?	N/A			
		Obstruction Type			Storm Grate/Utility Type

N/A			N/A	
					Yes	Surface Condition? (G/P)	Good		
					N/A	Curb Slope (%)	3.4

<div>Street 1 Name<div>BARBEE DR</div></div> <div>Stop Condition-Street 1<div>StopSign</div></div> <div>Street 2 Name<div>SPRING PARK DR</div></div> <div>Stop Condition-Street 2<div>None</div></div>	<div>Possible Solutions:</div> <div>Remove &amp; Replace Curb Ramp With Two New Directional Ramps or Equivalent.</div>			Compliance	Description	Data	Compliance	Description	Data
	N/A	Ramp Length (in)	49.0	Yes	BlendTrans Slope (%)	1.0			
	No	Ramp Width (in)	37.0	No	BlendTrans XSlope (%)	2.5			
	N/A	Flare Type LT	N/A	N/A	Flare Type RT	N/A			
	N/A	Flare Slope LT (%)	N/A	N/A	Flare Slope RT (%)	N/A			
	N/A	Flare Traversable LT?	N/A	N/A	Flare Traversable RT?	N/A			
	N/A	Landing Length (in)	N/A	N/A	DWS Provided?	N/A			
	N/A	Landing Width (in)	N/A	N/A	DWS Contrast?	N/A			
	N/A	Landing Slope (%)	N/A	N/A	DWS Length (in)	N/A
