## Access Compliance Report Public Rights-of-Way (Curb Ramps)

Intersection ID: 10026162 Main Street: ESTELLE\_ST Cross Street: N/A Location: E

ADA ID: 1E9803C9BB42 Ramp Type: Perp Initial Pass/Fail: Fail Overall Compliance: No Severity Score: 33.75

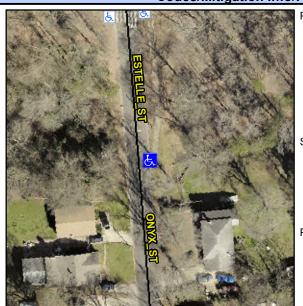
Field Measurements/Component Compilance								
Comp	liance Description	Data	Comp	liance Description	Data			
N/A	Ramp Length (in)	89.0	Yes	Ramp Slope (%)	6.0			
No	Ramp Width (in)	46.0	No	Ramp XSlope (%)	8.3			
N/A	Flare Type LT	N/A	N/A	Flare Type RT	N/A			
N/A	Flare Slope LT (%)	N/A	N/A	Flare Slope RT (%)	N/A			
N/A	Flare Traversable LT?	N/A	N/A	Flare Traversable RT?	N/A			
N/A	Landing Length (in)	N/A	N/A	DWS Provided?	N/A			
N/A	Landing Width (in)	N/A	N/A	DWS Contrast?	N/A			
N/A	Landing Slope (%)	N/A	N/A	DWS Length (in)	N/A			
N/A	Landing X Slope (%)	N/A	N/A	DWS Full Width?	N/A			
N/A	Landing Curb? (Y/N)	N/A	N/A	DWS Offset (in)	N/A			
N/A	Shared Landing?	N/A						
N/A	Gutter Ponding?	N/A	N/A	Gutter Slope (%)	N/A			
N/A	Gutter Lip Ht (in)	N/A	N/A	Gutter X Slope (%)	N/A			
N/A	Painted X Walk1?	No	N/A	Painted X Walk2?	N/A			
	X Walk 1 Direction	To W		X Walk 2 Direction	N/A			
N/A	X Walk 1 Width (in)	N/A	N/A	X Walk 2 Width (in)	N/A

X Walk 1 Slope (%)	2.1		X Walk 2 Slope (%)	N/A			
	X Walk 1 X Slope (%)	9.0		X Walk 2 X Slope (%)	N/A			
N/A	Ramp inside XWalk1?	N/A	N/A	Ramp inside XWalk2?	N/A			
	Road Slope (%)	N/A	N/A	Clear Space?	N/A			
	Road X Slope (%)	N/A	N/A	Clear Space to XWalk (in)	N/A			
N/A	Any Obstructions?	N/A	N/A	Storm Grate/Utility Hazard?	N/A			
	Obstruction Type			Storm Grate/Utility Type				
		N/A			N/A			
			Yes	Surface Condition? (G/P)	Good			
	William Street Street

ossible Solutions:	9			
Remove & Replace Entire Ramp.				
	N			
	N			
	N			
	N			
	N			
urveyor Notes:	N			
N/A	N			
	N			
	N			
	N			
ROW/ADA:	N			
Not Found, R304.5.1, R304.5.3	N			
	N			
	N

N/
PROW/ADA:				N/
Not Found,	R304.5.1, R304.5	.3		N/
				N/
				N/
				N/
Total Cost:	¢.		1850.00	N/
iolai Cost.	\$		1000.00
