Access Compliance Report

Public Rights-of-Way

(Curb Ramps)

Intersection ID: 50271	Main Street: CLANTON_RD	Cross Street: SOUTH_BV	Location: SW
ADA ID: 1E9AC6EB9983	Ramp Type: Perp	Initial Pass/Fail: Fail	Overall Compliance: No
			Severity Score: 13.75

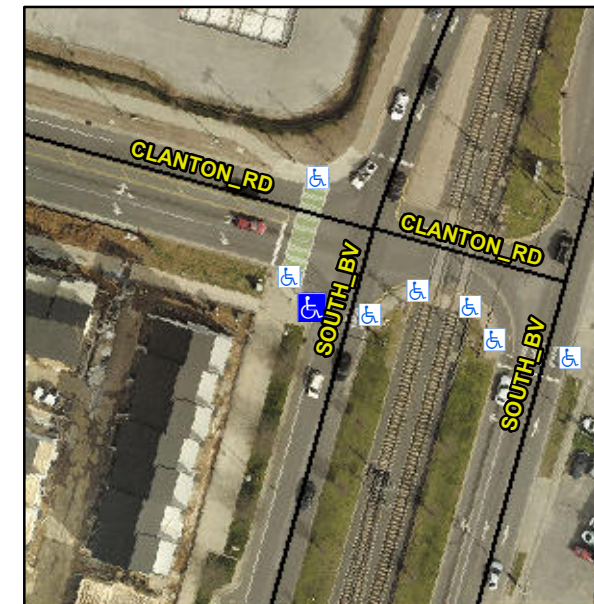
Compliance	Description	Data	Compliance	Description	Data
N/A	Ramp Length (in)	72.0	No	Ramp Slope (%)	9.4
Yes	Ramp Width (in)	48.0	Yes	Ramp XSlope (%)	3.0
N/A	Flare Type LT	N/A	N/A	Flare Type RT	N/A
N/A	Flare Slope LT (%)	N/A	N/A	Flare Slope RT (%)	N/A
N/A	Flare Traversable LT?	N/A	N/A	Flare Traversable RT?	N/A
N/A	Landing Length (in)	N/A	N/A	DWS Provided?	N/A
N/A	Landing Width (in)	N/A	N/A	DWS Contrast?	N/A
N/A	Landing Slope (%)	N/A	N/A	DWS Length (in)	N/A
N/A	Landing X Slope (%)	N/A	N/A	DWS Full Width?	N/A
N/A	Landing Curb? (Y/N)	N/A	N/A	DWS Offset (in)	N/A
N/A	Shared Landing?	N/A			
N/A	Gutter Ponding?	N/A	N/A	Gutter Slope (%)	N/A
N/A	Gutter Lip Ht (in)	N/A	N/A	Gutter X Slope (%)	N/A
N/A	Painted X Walk1?	Yes	N/A	Painted X Walk2?	N/A
	X Walk 1 Direction	To SE		X Walk 2 Direction	N/A
N/A	X Walk 1 Width (in)	125.0	N/A	X Walk 2 Width (in)	N/A
	X Walk 1 Slope (%)	1.8		X Walk 2 Slope (%)	N/A
	X Walk 1 X Slope (%)	3.6		X Walk 2 X Slope (%)	N/A

N/A	Ramp inside XWalk1?	Yes	N/A	Ramp inside XWalk2?	N/A
	Road Slope (%)	N/A	N/A	Clear Space?	N/A
	Road X Slope (%)	N/A	N/A	Clear Space to XWalk (in)	N/A
N/A	Any Obstructions?	N/A	N/A	Storm Grate/Utility Hazard?	N/A
	Obstruction Type			Storm Grate/Utility Type	
		N/A			N/A
			Yes	Surface Condition? (G/P)	Good

Remove & Replace Entire Ramp.
