Access Compliance Report

Public Rights-of-Way

(Curb Ramps)

Intersection ID: 23662	Main Street: CARMEL_RD	Cross Street: RED_OAK_LN	Location: SE
ADA ID: 1E9FB5BD7331	Ramp Type: MedianPerp	Initial Pass/Fail: Fail	Overall Compliance: No
Severity Score: 13.75			
Codes/Mitigation Info/Possible Solution		Field Measurements/Component Compliance

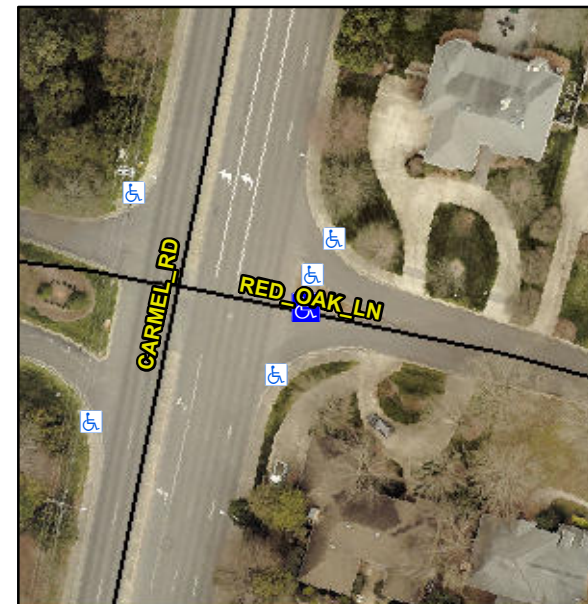
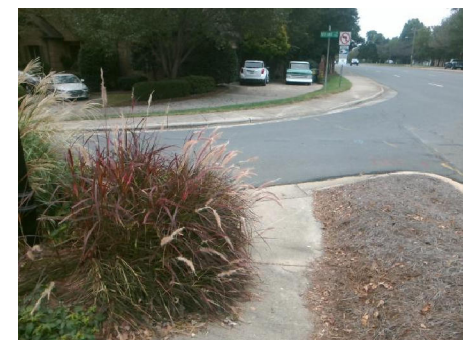
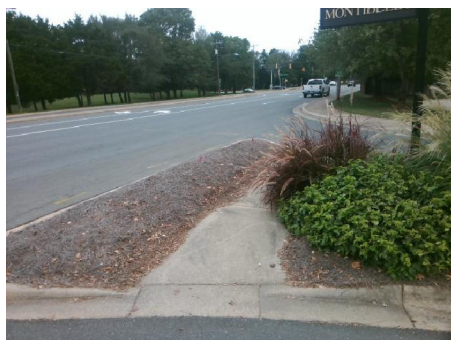
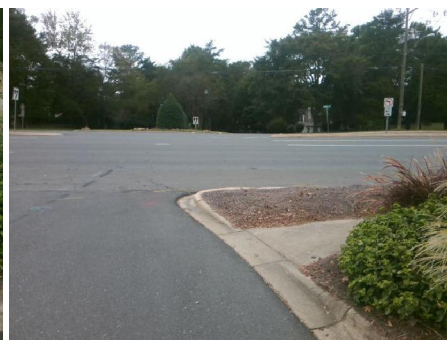
R304.2.2

Compliance	Description	Data	Compliance	Description	Data
N/A	Ramp Length (in)	66.0	No	Ramp Slope (%)	11.1
Yes	Ramp Width (in)	52.0	Yes	Ramp XSlope (%)	4.3
N/A	Flare Type LT	N/A	N/A	Flare Type RT	N/A
N/A	Flare Slope LT (%)	N/A	N/A	Flare Slope RT (%)	N/A
N/A	Flare Traversable LT?	N/A	N/A	Flare Traversable RT?	N/A
N/A	Landing Length (in)	N/A	N/A	DWS Provided?	N/A
N/A	Landing Width (in)	N/A	N/A	DWS Contrast?	N/A
N/A	Landing Slope (%)	N/A	N/A	DWS Length (in)	N/A
N/A	Landing X Slope (%)	N/A	N/A	DWS Full Width?	N/A
N/A	Landing Curb? (Y/N)	N/A	N/A	DWS Offset (in)	N/A
N/A	Shared Landing?	N/A			
N/A	Gutter Ponding?	N/A	N/A	Gutter Slope (%)	N/A
N/A	Gutter Lip Ht (in)	N/A	N/A	Gutter X Slope (%)	N/A
N/A	Painted X Walk1?	No	N/A	Painted X Walk2?	N/A
	X Walk 1 Direction	To SW		X Walk 2 Direction	N/A
N/A	X Walk 1 Width (in)	N/A	N/A	X Walk 2 Width (in)	N/A
	X Walk 1 Slope (%)	4.4		X Walk 2 Slope (%)	N/A
	X Walk 1 X Slope (%)	4.9		X Walk 2 X Slope (%)	N/A

N/A	Ramp inside XWalk1?	N/A	N/A	Ramp inside XWalk2?	N/A
	Road Slope (%)	N/A	N/A	Clear Space?	N/A
	Road X Slope (%)	N/A	N/A	Clear Space to XWalk (in)	N/A
N/A	Any Obstructions?	N/A	N/A	Storm Grate/Utility Hazard?	N/A
	Obstruction Type			Storm Grate/Utility Type	
		N/A			N/A
			Yes	Surface Condition? (G/P)	Good

Possible Solutions:

Remove & Replace Entire Ramp.

Total Cost: \$ 1650.00
