# Access Compliance Report

## Public Rights-of-Way

### (Curb Ramps)

Intersection ID: 11993	Main Street: MEREDITH_AV	Cross Street: PRUITT_ST	Location: NE
ADA ID: 1EADF8098999	Ramp Type: Perp	Initial Pass/Fail: Fail	Overall Compliance: No
			Severity Score: 33.75

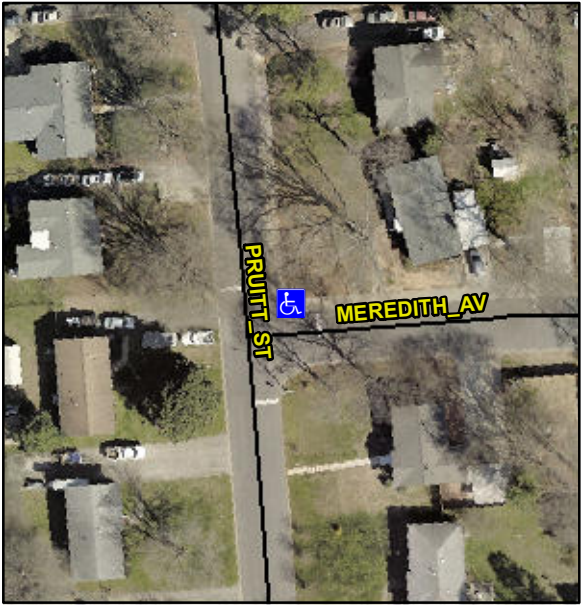
Possible Solutions:		<b>Compliance</b>	<b>Description</b>	<b>Data</b>
	<b>Remove &amp; Replace Entire Ramp.</b>		<b>N/A</b>	Ramp Length (in)	<b>76.0</b>
			<b>No</b>	Ramp Width (in)	<b>47.5</b>
			<b>N/A</b>	Flare Type LT	<b>N/A</b>
			<b>N/A</b>	Flare Slope LT (%)	<b>N/A</b>
			<b>N/A</b>	Flare Traversable LT?	<b>N/A</b>
			<b>N/A</b>	Landing Length (in)	<b>N/A</b>
			<b>N/A</b>	Landing Width (in)	<b>N/A</b>
			<b>N/A</b>	Landing Slope (%)	<b>N/A</b>
			<b>N/A</b>	Landing X Slope (%)	<b>N/A</b>
<p>Surveyor Notes:</p> <p><b>N/A</b></p> <p>PROW/ADA:</p> <p><b>Not Found, R304.5.1, R304.5.3</b></p>			<b>N/A</b>	Flare Type RT	<b>N/A</b>
			<b>N/A</b>	Flare Slope RT (%)	<b>N/A</b>
			<b>N/A</b>	Flare Traversable RT?	<b>N/A</b>
			<b>N/A</b>	DWS Provided?	<b>N/A</b>
			<b>N/A</b>	DWS Contrast?	<b>N/A</b>
			<b>N/A</b>	DWS Length (in)	<b>N/A</b>

<b>N/A</b>	DWS Full Width?	<b>N/A</b>
			<b>N/A</b>	DWS Offset (in)	<b>N/A</b>
			<b>N/A</b>	Shared Landing?	<b>N/A</b>
			<b>N/A</b>	Gutter Ponding?	<b>N/A</b>
			<b>N/A</b>	Gutter Lip Ht (in)	<b>N/A</b>
			<b>N/A</b>	Painted X Walk1?	<b>No</b>
				X Walk 1 Direction	<b>To S</b>
			<b>N/A</b>	X Walk 1 Width (in)	<b>N/A</b>
				X Walk 1 Slope (%)	<b>0.3</b>
				X Walk 1 X Slope (%)	<b>6.6</b>
			<b>N/A</b>	Ramp inside XWalk1?	<b>N/A</b>
				Road Slope (%)	<b>6.6</b>
				Road X Slope (%)	<b>0.3</b>
			<b>N/A</b>	Any Obstructions?	<b>N/A</b>
Total Cost:		<b>\$ 1850.00</b>		Obstruction Type	
			<b>N/A</b>		<b>N/A</b>
			<b>Yes</b>	Surface Condition? (G/P)	<b>Good</b>
