## Access Compliance Report Public Rights-of-Way (Curb Ramps)

Main Of		0	4				I	014/
Intersection ID: 20407	Main Str	Main Street: CAMERON_VALLEY_PY 0			COLTSGATE_RD	Location:	SW		
ADA ID: 1EB579ED01FE	Ramp Ty	Ramp Type: PerpDiag In			ail: Fail Overall (	o Severity Score:	37.5		
Codes/Mitigation Info/Possible Solution				Field Measurements/Component Compliance					
		Possible Solutions:		Compliance Description		Data Compliance Description		Data	
		Remove & Replace Curb Ramp With Two New Directional Ramps or Equivalent.	/ith	N/A	Ramp Length (in)	82.5	No	Ramp Slope (%)	16.2
				Yes	Ramp Width (in)	48.0	No	Ramp XSlope (%)	5.5
				N/A	Flare Type LT	N/A	N/A	Flare Type RT	N/A
				N/A	Flare Slope LT (%)	N/A	N/A	Flare Slope RT (%)	N/A
COLISCO	CALL AL			N/A	Flare Traversable LT?	N/A	N/A	Flare Traversable RT?	N/A
RD 6.				N/A	Landing Length (in)	N/A	N/A	DWS Provided?	N/A
A CONTRACTOR		Surveyor Notes:		N/A	Landing Width (in)	N/A	N/A	DWS Contrast?	N/A
the second s		N/A		N/A	Landing Slope (%)	N/A	N/A	DWS Length (in)	N/A

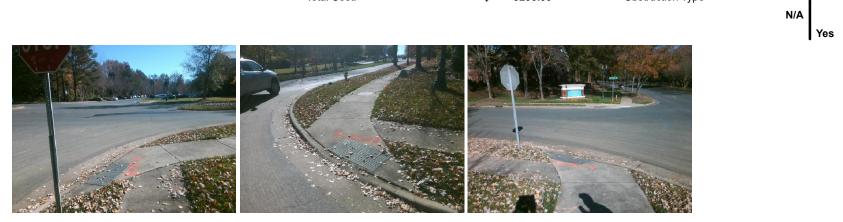
CONTRACTOR AND A				N/A	Landing X Slope (%)	N/A	N/A	DWS Full Width?	N/A
	5			N/A	Landing Curb? (Y/N)	N/A	N/A	DWS Offset (in)	N/A
				N/A	Shared Landing?	N/A			
	11 Marto	PROW/ADA:		N/A	Gutter Ponding?	N/A	N/A	Gutter Slope (%)	N/A
		R304.2.2, R304.5.3		N/A	Gutter Lip Ht (in)	N/A	N/A	Gutter X Slope (%)	N/A
		,		N/A	Painted X Walk1?	No	N/A	Painted X Walk2?	No
					X Walk 1 Direction	To SE		X Walk 2 Direction	To NE
				N/A	X Walk 1 Width (in)	N/A	N/A	X Walk 2 Width (in)	N/A
Street 1 Name CA	AMERON VALLEY PY				X Walk 1 Slope (%)	4.7		X Walk 2 Slope (%)	0.5
Stop Condition-Street 2	None				X Walk 1 X Slope (%)	1.9		X Walk 2 X Slope (%)	4.4
Street 2 Name	COLTSGATE RD			N/A	Ramp inside XWalk1?	N/A	N/A	Ramp inside XWalk2?	N/A
Stop Condition-Street 1	StopSign				Road Slope (%)	5.8	N/A	Clear Space?	N/A

-				Road X Slope (%)	0.3	N/A	Clear Space to XWalk (in)	N/A
				N/A	Any Obstructions?	N/A	N/A	Storm Grate/Utility Hazard?	N/A
		Total Cost: \$ 32	200.00		Obstruction Type			Storm Grate/Utility Type	
						N/A			N/A

s Surface Condition? (G/P) Good
