# Access Compliance Report

## Public Rights-of-Way

### (Curb Ramps)

Intersection ID: 10034415	Main Street: PIERSON_DR	Cross Street: N/A	Location: W
ADA ID: 1ECCD7DEA8FA	Ramp Type: Perp	Initial Pass/Fail: Fail	Overall Compliance: No
		Severity Score: 1.25

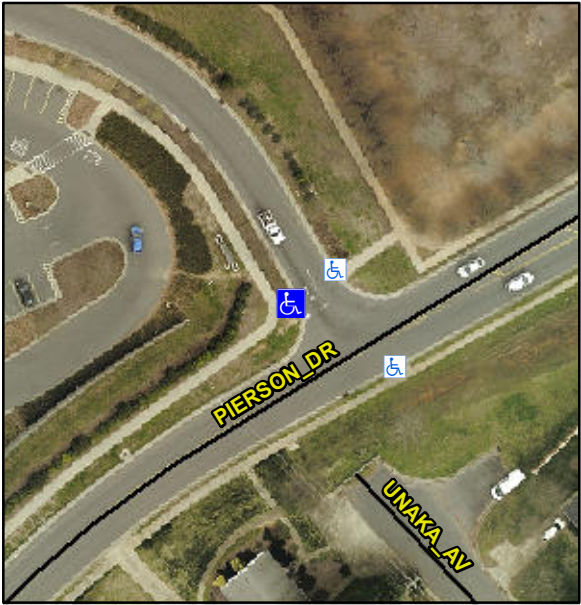
Possible Solutions:		<b>Compliance</b>	<b>Description</b>	<b>Data</b>
	<b>Remove &amp; Replace Entire Ramp.</b>		<b>Yes</b>	Ramp Length (in)	72.0
			<b>No</b>	Ramp Width (in)	48.0
			<b>N/A</b>	Flare Type LT	N/A
			<b>N/A</b>	Flare Slope LT (%)	N/A
			<b>N/A</b>	Flare Traversable LT?	N/A
			<b>N/A</b>	Landing Length (in)	N/A
			<b>N/A</b>	Landing Width (in)	N/A
			<b>N/A</b>	Landing Slope (%)	N/A
			<b>N/A</b>	Landing X Slope (%)	N/A
<p>Surveyor Notes:</p> <p><b>N/A</b></p> <p>PROW/ADA:</p> <p><b>Not Found, R304.5.3</b></p>			<b>N/A</b>	Flare Type RT	N/A
			<b>N/A</b>	Flare Slope RT (%)	N/A
			<b>N/A</b>	Flare Traversable RT?	N/A
			<b>N/A</b>	DWS Provided?	N/A
			<b>N/A</b>	DWS Contrast?	N/A
			<b>N/A</b>	DWS Length (in)	N/A
			<b>N/A</b>	DWS Full Width?	N/A
			<b>N/A</b>	DWS Offset (in)	N/A
			<b>N/A</b>	Gutter Ponding?	N/A

<b>N/A</b>	Gutter Lip Ht (in)	0.5
			<b>No</b>	Painted X Walk1?	N/A
				X Walk 1 Direction	To E
			<b>N/A</b>	X Walk 1 Width (in)	N/A
				X Walk 1 Slope (%)	3.3
				X Walk 1 X Slope (%)	2.9
			<b>N/A</b>	Ramp inside XWalk1?	N/A
			<b>N/A</b>	Road Slope (%)	N/A
			<b>N/A</b>	Road X Slope (%)	N/A
			<b>N/A</b>	Any Obstructions?	N/A
				Obstruction Type	
Total Cost:			<b>N/A</b>	Storm Grate/Utility Hazard?	N/A
				Storm Grate/Utility Type	
			<b>N/A</b>		N/A
			<b>Yes</b>	Surface Condition? (G/P)	Good
