Access Compliance Report Public Rights-of-Way (Curb Ramps)

Intersection ID: 22153 Main Street: PUDDINGSTONE_CV Cross Street: STOCKTIE_RD Location: E

ADA ID: 1ED066965832 Ramp Type: PerpDiag Initial Pass/Fail: Fail Overall Compliance: No Severity Score: 21.25

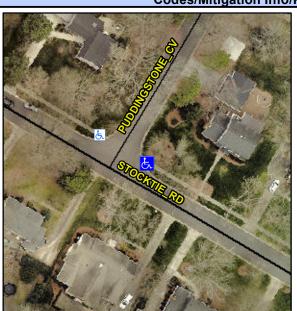
Not Found, R304.5.1, R304.2.2

Field Measure	ements/C	<u>ompo</u>	nent Compliance	
Compliance Description		Data	Compliance Description		Data
N/A	Ramp Length (in)	93.0	No	Ramp Slope (%)	10.3
No	Ramp Width (in)	38.0	Yes	Ramp XSlope (%)	1.6
N/A	Flare Type LT	N/A	N/A	Flare Type RT	N/A
N/A	Flare Slope LT (%)	N/A	N/A	Flare Slope RT (%)	N/A
N/A	Flare Traversable LT?	N/A	N/A	Flare Traversable RT?	N/A
N/A	Landing Length (in)	N/A	N/A	DWS Provided?	N/A
N/A	Landing Width (in)	N/A	N/A	DWS Contrast?	N/A
N/A	Landing Slope (%)	N/A	N/A	DWS Length (in)	N/A
N/A	Landing X Slope (%)	N/A	N/A	DWS Full Width?	N/A
N/A	Landing Curb? (Y/N)	N/A	N/A	DWS Offset (in)	N/A
N/A	Shared Landing?	N/A			
N/A	Gutter Ponding?	N/A	N/A	Gutter Slope (%)	N/A
N/A	Gutter Lip Ht (in)	N/A	N/A	Gutter X Slope (%)	N/A
N/A	Painted X Walk1?	No	N/A	Painted X Walk2?	No
	X Walk 1 Direction	To NW		X Walk 2 Direction	To SW
N/A	X Walk 1 Width (in)	N/A	N/A	X Walk 2 Width (in)	N/A
	X Walk 1 Slope (%)	1.4		X Walk 2 Slope (%)	5.3

X Walk 1 X Slope (%)	6.4		X Walk 2 X Slope (%)	3.8
N/A	Ramp inside XWalk1?	N/A	N/A	Ramp inside XWalk2?	N/A
	Road Slope (%)	3.5	N/A	Clear Space?	N/A
	Road X Slope (%)	3.1	N/A	Clear Space to XWalk (in)	N/A
N/A	Any Obstructions?	N/A	N/A	Storm Grate/Utility Hazard?	N/A

Remove & Replace Curb Ramp With Two New Directional Ramps or Equivalent.
