Intersection ID: 10169	Main Street: BRICE_ST	Cross Street: MORSON_ST	Location:	SE
ADA ID: 1ED72DB52AE3	Ramp Type: PerpDiag	Initial Pass/Fail: Fail	Overall Compliance: No	Severity Score: 12.5

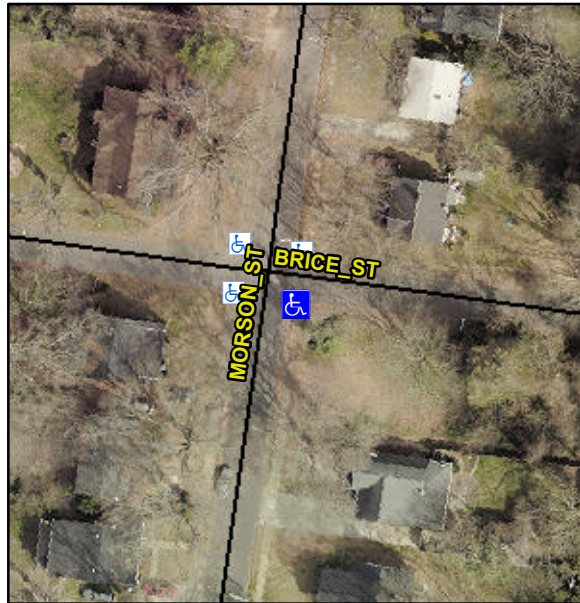
Not Found, R304.2.2

Compliance	Description	Data	Compliance	Description	Data
N/A	Ramp Length (in)	25.0	No	Ramp Slope (%)	10.9
Yes	Ramp Width (in)	48.0	Yes	Ramp XSlope (%)	0.4
N/A	Flare Type LT	N/A	N/A	Flare Type RT	N/A
N/A	Flare Slope LT (%)	N/A	N/A	Flare Slope RT (%)	N/A
N/A	Flare Traversable LT?	N/A	N/A	Flare Traversable RT?	N/A
N/A	Landing Length (in)	N/A	N/A	DWS Provided?	N/A
N/A	Landing Width (in)	N/A	N/A	DWS Contrast?	N/A
N/A	Landing Slope (%)	N/A	N/A	DWS Length (in)	N/A
N/A	Landing X Slope (%)	N/A	N/A	DWS Full Width?	N/A
N/A	Landing Curb? (Y/N)	N/A	N/A	DWS Offset (in)	N/A
N/A	Shared Landing?	N/A			
N/A	Gutter Ponding?	Yes	N/A	Gutter Slope (%)	N/A
N/A	Gutter Lip Ht (in)	2.0	N/A	Gutter X Slope (%)	N/A
N/A	Painted X Walk1?	No	N/A	Painted X Walk2?	No
	X Walk 1 Direction	To N		X Walk 2 Direction	To W
N/A	X Walk 1 Width (in)	N/A	N/A	X Walk 2 Width (in)	N/A
	X Walk 1 Slope (%)	0.4		X Walk 2 Slope (%)	2.0
	X Walk 1 X Slope (%)	0.5		X Walk 2 X Slope (%)	0.5

N/A	Ramp inside XWalk1?	N/A	N/A	Ramp inside XWalk2?	N/A
	Road Slope (%)	1.6	N/A	Clear Space?	N/A
	Road X Slope (%)	0.5	N/A	Clear Space to XWalk (in)	N/A
N/A	Any Obstructions?	N/A	N/A	Storm Grate/Utility Hazard?	N/A
	Obstruction Type			Storm Grate/Utility Type	
		N/A			N/A
			Yes	Surface Condition? (G/P)	Good

Remove & Replace Curb Ramp With Two New Directional Ramps or Equivalent.

Total Cost: \$ 3200.00
