## **Access Compliance Report Public Rights-of-Way** (Curb Ramps)

Intersection ID: 14178 Main Street: E 8TH ST **Cross Street: RIDGEWAY AV** Location:

**ADA ID: 1EDDD29EAAE2** Ramp Type: PerpDiag Initial Pass/Fail: Fail **Overall Compliance: No** Severity Score: 13.75

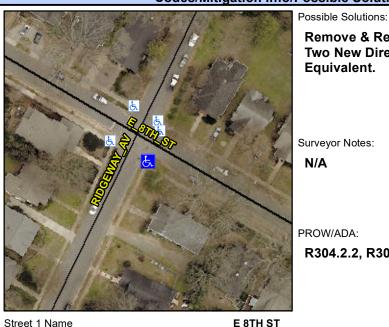
R304.2.2, R304.5.3

Compliance Description		Data	Comp	liance Description
N/A	Ramp Length (in)	56.0	No	Ramp Slope (%)
Yes	Ramp Width (in)	156.0	No	Ramp XSlope (%)
N/A	Flare Type LT	N/A	N/A	Flare Type RT
N/A	Flare Slope LT (%)	N/A	N/A	Flare Slope RT (%)
N/A	Flare Traversable LT?	N/A	N/A	Flare Traversable RT?
N/A	Landing Length (in)	N/A	N/A	DWS Provided?
N/A	Landing Width (in)	N/A	N/A	DWS Contrast?
N/A	Landing Slope (%)	N/A	N/A	DWS Length (in)
N/A	Landing X Slope (%)	N/A	N/A	DWS Full Width?
N/A	Landing Curb? (Y/N)	N/A	N/A	DWS Offset (in)
N/A	Shared Landing?	N/A		
N/A	Gutter Ponding?	N/A	N/A	Gutter Slope (%)
N/A	Gutter Lip Ht (in)	N/A	N/A	Gutter X Slope (%)
N/A	Painted X Walk1?	No	N/A	Painted X Walk2?
	X Walk 1 Direction	To NE		X Walk 2 Direction
N/A	X Walk 1 Width (in)	N/A	N/A	X Walk 2 Width (in)
	X Walk 1 Slope (%)	2.7		X Walk 2 Slope (%)
	X Walk 1 X Slope (%)	1.5		X Walk 2 X Slope (%)
N/A	Ramp inside XWalk1?	N/A	N/A	Ramp inside XWalk2?

Road Slope (%)	1.1	N/A	Clear Space?
	Road X Slope (%)	1.6	N/A	Clear Space to XWalk (in)
N/A	Any Obstructions?	N/A	N/A	Storm Grate/Utility Hazard?

Street 1 Name Stop Condition-Street 2 Street 2 Name Stop Condition-Street 1 Remove & Replace Curb Ramp With Two New Directional Ramps or Equivalent.

Total Cost: 3200.00
