Access Compliance Report Public Rights-of-Way (Curb Ramps)

Intersection ID: 28391 Main Street: HIGHLANDS_CROSSING_DR Cross Street: ROYAL_HIGHLANDS_CT Location: E

ADA ID: 1EFA658A075E Ramp Type: Perp Initial Pass/Fail: Fail Overall Compliance: No Severity Score: 12.5

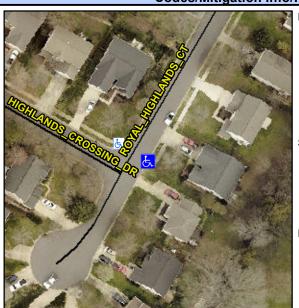
Comp	liance Description	Data		liance Description	Data
N/A	Ramp Length (in)	47.0	Yes	Ramp Slope (%)	5.7
Yes	Ramp Width (in)	48.0	No	No Ramp XSlope (%)	
N/A	Flare Type LT	N/A	N/A	Flare Type RT	N/A
N/A	Flare Slope LT (%)	N/A	N/A	Flare Slope RT (%)	N/A
N/A	Flare Traversable LT?	N/A	N/A	Flare Traversable RT?	N/A
N/A	Landing Length (in)	N/A	N/A	DWS Provided?	N/A
N/A	Landing Width (in)	N/A	N/A	DWS Contrast?	N/A
N/A	Landing Slope (%)	N/A	N/A	DWS Length (in)	N/A
N/A	Landing X Slope (%)	N/A	N/A	DWS Full Width?	N/A
N/A	Landing Curb? (Y/N)	N/A	N/A	DWS Offset (in)	N/A
N/A	Shared Landing?	N/A			
N/A	Gutter Ponding?	N/A	N/A	Gutter Slope (%)	N/A
N/A	Gutter Lip Ht (in)	N/A	N/A	Gutter X Slope (%)	N/A
N/A	Painted X Walk1?	No	N/A	Painted X Walk2?	N/A
	X Walk 1 Direction	To NW		X Walk 2 Direction	N/A
N/A	X Walk 1 Width (in)	N/A	N/A	X Walk 2 Width (in)	N/A
	X Walk 1 Slope (%)	2.2		X Walk 2 Slope (%)	N/A
	X Walk 1 X Slope (%)	3.7		X Walk 2 X Slope (%)	N/A

N/A	Ramp inside XWalk1?	N/A	N/A	Ramp inside XWalk2?	N/A
	Road Slope (%)	N/A	N/A	Clear Space?	N/A
	Road X Slope (%)	N/A	N/A	Clear Space to XWalk (in)	N/A
N/A	Any Obstructions?	N/A	N/A	Storm Grate/Utility Hazard?	N/A
	Obstruction Type			Storm Grate/Utility Type	
		N/A			N/A

Possible Solutions:	Co		
Remove & Replace Entire Ramp.			
	Ye		
	N/		
Surveyor Notes:	N/		
N/A	N/		
	N/		
	N/		
	N/		
PROW/ADA:	N/		
Not Found, R304.5.3	N/		
	N/		
	N/

Total Cost:	\$	1850.00
