Access Compliance Report Public Rights-of-Way (Curb Ramps)

Intersection ID: 9326 Main Street: FAIRMONT_ST Cross Street: OAKLAWN_AV Location: SE **Overall Compliance: No** Severity Score: 21.25 **ADA ID: 1EFD8C04B370** Ramp Type: Perp Initial Pass/Fail: Fail

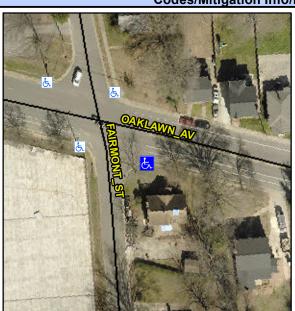
Field Measurements/Component Compliance								
Comp	liance Description	Data	Comp	liance	Description	Data		
N/A	Ramp Length (in)	25.5	No	Ramp	Slope (%)	11.8		
No	Ramp Width (in)	43.0	Yes	Ramp XSlope (%)		1.7		
N/A	Flare Type LT	N/A	N/A	Flare Type RT		N/A		
N/A	Flare Slope LT (%)	N/A	N/A	Flare Slope RT (%)		N/A		
N/A	Flare Traversable LT?	N/A	N/A	Flare Traversable RT?		N/A		
N/A	Landing Length (in)	N/A	N/A	DWS Provided?		N/A		
N/A	Landing Width (in)	N/A	N/A	DWS Contrast?		N/A		
N/A	Landing Slope (%)	N/A	N/A	DWS	Length (in)	N/A		
N/A	Landing X Slope (%)	N/A	N/A	DWS	Full Width?	N/A		
N/A	Landing Curb? (Y/N)	N/A	N/A	DWS	Offset (in)	N/A		
N/A	Shared Landing?	N/A						
N/A	Gutter Ponding?	N/A	N/A	Gutte	r Slope (%)	N/A		
N/A	Gutter Lip Ht (in)	N/A	N/A	Gutte	r X Slope (%)	N/A		
N/A	Painted X Walk1?	No	N/A	Paint	ed X Walk2?	N/A		
	X Walk 1 Direction	To NW		X Wa	lk 2 Direction	N/A		
N/A	X Walk 1 Width (in)	N/A	N/A	X Wa	lk 2 Width (in)	N/A

X Walk 1 Slope (%)	1.0		X Wa	lk 2 Slope (%)	N/A		
	X Walk 1 X Slope (%)	2.6		X Wa	lk 2 X Slope (%)	N/A		
N/A	Ramp inside XWalk1?	N/A	N/A	Ramp	inside XWalk2?	N/A		
	Road Slope (%)	N/A	N/A	Clear	Space?	N/A		
	Road X Slope (%)	N/A	N/A	Clear	Space to XWalk (in)	N/A		
N/A	Any Obstructions?	N/A	N/A	Storm	n Grate/Utility Hazard?	N/A		
	Obstruction Type			Storm	n Grate/Utility Type			
		N/A				N/A		
			Yes	Surfa	ce Condition? (G/P)	Good

Possible Solutions:	9
Remove & Replace Entire Ramp.	
·	1
	N
	1
	1
	1
Surveyor Notes:	1
N/A	1
	1
	1
	1
PROW/ADA:	1
Not Found, R304.5.1, R304.2.2	N
	N
	ŀ
	r
