## **Access Compliance Report Public Rights-of-Way** (Curb Ramps)

Intersection ID: 9765 Main Street: RUSH\_WIND\_DR Cross Street: TINNIN\_AV Location: NW

Initial Pass/Fail: Fail **Overall Compliance: No** ADA ID: 1F002D036F8D Ramp Type: Perp Severity Score: 48.75

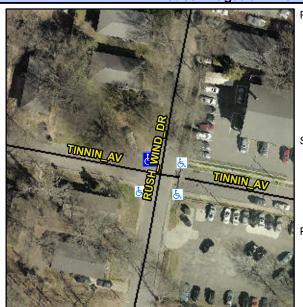
Comp	liance Descri	ption	Data	Comp	liance	Description	Data
N/A	Ramp Length	ı (in)	67.5	Yes	Ramp	Slope (%)	7.9
No	Ramp Width	(in)	40.0	No	Ramp	XSlope (%)	11.0
N/A	Flare Type L	Γ	N/A	N/A	Flare	Type RT	N/A
N/A	Flare Slope I	_T (%)	N/A	N/A	Flare	Slope RT (%)	N/A
N/A	Flare Travers	sable LT?	N/A	N/A	Flare	Traversable RT?	N/A
N/A	Landing Leng	gth (in)	N/A	N/A	DWS	Provided?	N/A
N/A	Landing Widt	h (in)	N/A	N/A	DWS	Contrast?	N/A
N/A	Landing Slop	e (%)	N/A	N/A	DWS	Length (in)	N/A
N/A	Landing X Sl	ope (%)	N/A	N/A	DWS	Full Width?	N/A
N/A	Landing Curb	? (Y/N)	N/A	N/A	DWS	Offset (in)	N/A
N/A	Shared Land	ing?	N/A				
N/A	Gutter Pondi	ng?	N/A	N/A	Gutte	r Slope (%)	N/A
N/A	Gutter Lip Ht	(in)	N/A	N/A	Gutte	r X Slope (%)	N/A
N/A	Painted X Wa	alk1?	No	N/A	Paint	ed X Walk2?	N/A
	X Walk 1 Dire	ection	To SW		X Wa	lk 2 Direction	N/A
N/A	X Walk 1 Wid	Ith (in)	N/A	N/A	X Wa	lk 2 Width (in)	N/A
	X Walk 1 Slo	pe (%)	3.9		X Wa	lk 2 Slope (%)	N/A

X Walk 1 X S	lope (%)	8.1		X Wa	lk 2 X Slope (%)	N/A
N/A	Ramp inside	XWalk1?	N/A	N/A	Ram	inside XWalk2?	N/A
	Road Slope (	%)	N/A	N/A	Clear	Space?	N/A
	Road X Slope	e (%)	N/A	N/A	Clear	Space to XWalk (in)	N/A
N/A	Any Obstruct	ions?	N/A	N/A	Storn	n Grate/Utility Hazard?	N/A
	Obstruction 7	уре			Storn	n Grate/Utility Type	
			N/A				N/A
				No	Surfa	ce Condition? (G/P)	Poor
		No.

Possible Solutions:	Co
Remove & Replace Entire Ramp.	N/A
-	No
	N/A
	N/A
	N/A
	N/A
Surveyor Notes:	N/A
N/A	N/A
	N/A
	N/A
	N/A
PROW/ADA:	N/A
R304.5.1, R304.5.3, R302.7	N/A
	N/A
	N//
	N/A
