# Access Compliance Report

## Public Rights-of-Way

### (Curb Ramps)

Intersection ID: 19392	Main Street: CREEKRIDGE_RD	Cross Street: CREEKWOOD_QUORUM_DR	Location: NE
ADA ID: 1F00F61CE9A9	Ramp Type: PerpDiag	Initial Pass/Fail: Fail	Overall Compliance: No
		Severity Score: 12.5

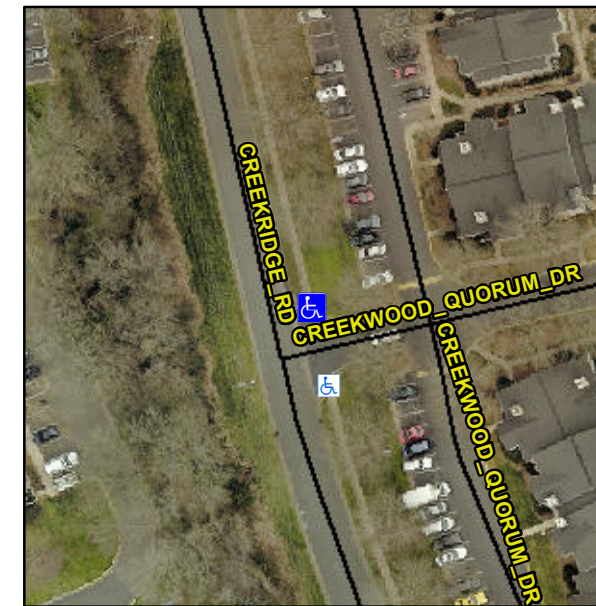
**Not Found, R304.5.3**

Compliance	Description	Data	Compliance	Description	Data
N/A	Ramp Length (in)	31.0	Yes	Ramp Slope (%)	6.3
Yes	Ramp Width (in)	48.0	No	Ramp XSlope (%)	6.8
N/A	Flare Type LT	N/A	N/A	Flare Type RT	N/A
N/A	Flare Slope LT (%)	N/A	N/A	Flare Slope RT (%)	N/A
N/A	Flare Traversable LT?	N/A	N/A	Flare Traversable RT?	N/A
N/A	Landing Length (in)	N/A	N/A	DWS Provided?	N/A
N/A	Landing Width (in)	N/A	N/A	DWS Contrast?	N/A
N/A	Landing Slope (%)	N/A	N/A	DWS Length (in)	N/A
N/A	Landing X Slope (%)	N/A	N/A	DWS Full Width?	N/A
N/A	Landing Curb? (Y/N)	N/A	N/A	DWS Offset (in)	N/A
N/A	Shared Landing?	N/A			
N/A	Gutter Ponding?	N/A	N/A	Gutter Slope (%)	N/A
N/A	Gutter Lip Ht (in)	N/A	N/A	Gutter X Slope (%)	N/A
N/A	Painted X Walk1?	No	N/A	Painted X Walk2?	No
	X Walk 1 Direction	To W		X Walk 2 Direction	To S
N/A	X Walk 1 Width (in)	N/A	N/A	X Walk 2 Width (in)	N/A
	X Walk 1 Slope (%)	2.7		X Walk 2 Slope (%)	2.1
	X Walk 1 X Slope (%)	0.7		X Walk 2 X Slope (%)	11.0

N/A	Ramp inside XWalk1?	N/A	N/A	Ramp inside XWalk2?	N/A
	Road Slope (%)	7.2	N/A	Clear Space?	N/A
	Road X Slope (%)	6.9	N/A	Clear Space to XWalk (in)	N/A
N/A	Any Obstructions?	N/A	N/A	Storm Grate/Utility Hazard?	N/A
	Obstruction Type			Storm Grate/Utility Type	
		N/A			N/A
		Yes		Surface Condition? (G/P)	Good

**Remove & Replace Curb Ramp With Two New Directional Ramps or Equivalent.**
