Access Compliance Report Public Rights-of-Way (Curb Ramps)

Intersection ID: N/AMain Street:SHARON_RIDGE_LNCross Street: N/ANADA ID: 1F0C0D11991ARamp Type:PerpInitial Pass/Fail:FailOverall Compliance: NoSeverity Score:25

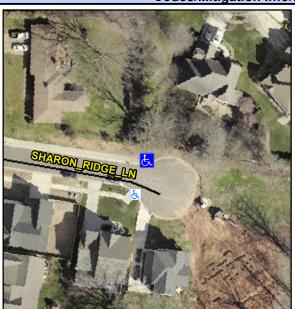
Field Measurements/Component Compliance							
Comp	liance Description	Data	Comp	liance	Description	Data	
N/A	Ramp Length (in)	72.0	No	Ramp	Slope (%)	8.7	
Yes	Ramp Width (in)	48.0	No	Ramp	XSlope (%)	5.6	
N/A	Flare Type LT	N/A	N/A	Flare	Type RT	N/A	
N/A	Flare Slope LT (%)	N/A	N/A	Flare	Slope RT (%)	N/A	
N/A	Flare Traversable LT?	N/A	N/A	Flare	Traversable RT?	N/A	
N/A	Landing Length (in)	N/A	N/A	DWS	Provided?	N/A	
N/A	Landing Width (in)	N/A	N/A	DWS	Contrast?	N/A	
N/A	Landing Slope (%)	N/A	N/A	DWS	Length (in)	N/A	
N/A	Landing X Slope (%)	N/A	N/A	DWS	Full Width?	N/A	
N/A	Landing Curb? (Y/N)	N/A	N/A	DWS	Offset (in)	N/A	
N/A	Shared Landing?	N/A					
N/A	Gutter Ponding?	N/A	N/A	Gutte	r Slope (%)	N/A	
N/A	Gutter Lip Ht (in)	N/A	N/A	Gutte	r X Slope (%)	N/A	
N/A	Painted X Walk1?	No	N/A	Paint	ed X Walk2?	N/A	
	X Walk 1 Direction	To S		X Wa	lk 2 Direction	N/A	
N/A	X Walk 1 Width (in)	N/A	N/A	X Wa	lk 2 Width (in)	N/A

X Walk 1 Slope (%)	1.0		X Wa	lk 2 Slope (%)	N/A	
	X Walk 1 X Slope (%)	7.8		X Wa	lk 2 X Slope (%)	N/A	
N/A	Ramp inside XWalk1?	N/A	N/A	Ram	inside XWalk2?	N/A	
	Road Slope (%)	N/A	N/A	Clear	Space?	N/A	
	Road X Slope (%)	N/A	N/A	Clear	Space to XWalk (in)	N/A	
N/A	Any Obstructions?	N/A	N/A	Storn	n Grate/Utility Hazard?	N/A	
	Obstruction Type			Storn	n Grate/Utility Type		
		N/A				N/A	
			Yes	Surfa	ce Condition? (G/P)	Good

Possible Solutions:	Co
Remove & Replace Entire Ramp.	N/
	Ye
	N/A
	N/
	N/
	N/
Surveyor Notes:	N/
N/A	N/
	N/
	N/
	N/
PROW/ADA:	N/
Not Found, R304.2.2, R304.5.3	N/A
	N/
	N/.
	N/.

1850.00
