Access Compliance Report

Public Rights-of-Way

(Curb Ramps)

| Intersection ID: 23690 | Main Street: CRESSIDA_DR | Cross Street: E WESTINGHOUSE BV | Location: SW |

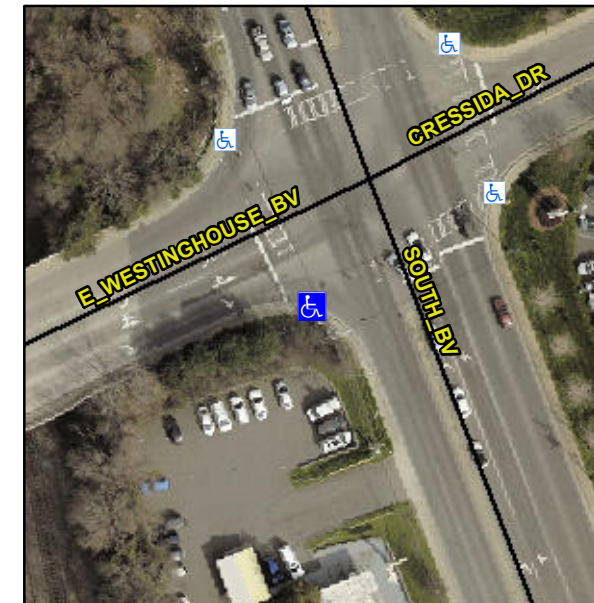
| ADA ID: 1F15BC4EB7D1 | Ramp Type: PerpDiag | Initial Pass/Fail: Fail | Overall Compliance: No |
| | | Severity Score: 12.5 | |

Not Found, R304.2.2

| Compliance | Description | Data | Compliance | Description | Data |
|---|---|---|---|---|---|
| N/A | Ramp Length (in) | 50.0 | No | Ramp Slope (%) | 10.1 |
| Yes | Ramp Width (in) | 48.0 | Yes | Ramp XSlope (%) | 1.6 |

Possible Solutions:

Remove & Replace Curb Ramp With Two New Directional Ramps or Equivalent.

Total Cost: \$ 3200.00

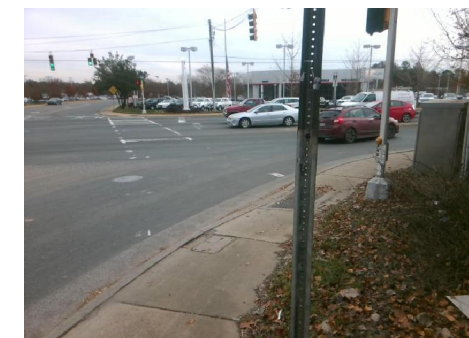
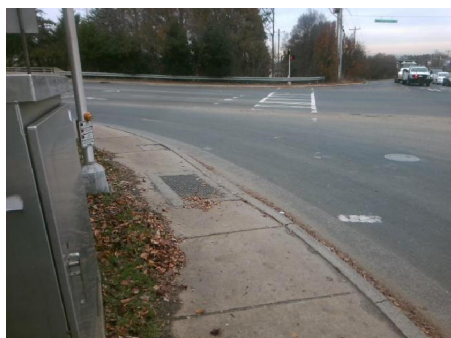
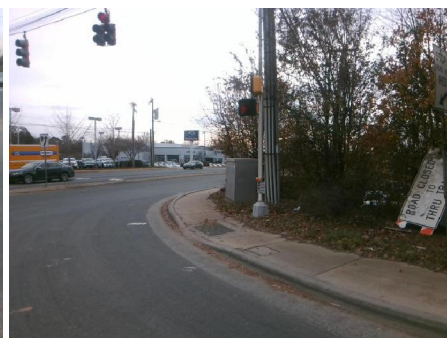
Street 1 Name SOUTH BV
 Stop Condition-Street 2 Signal
 Street 2 Name E WESTINGHOUSE BV
 Stop Condition-Street 1 Signal
