## Access Compliance Report Public Rights-of-Way (Curb Ramps)

Intersection ID: 4394 Main Street: OLD\_STATESVILLE\_RD Cross Street: VICTORIA\_AV Location: NW

ADA ID: 1F20004C2D10 Ramp Type: PerpDiag Initial Pass/Fail: Fail Overall Compliance: No Severity Score: 47.5

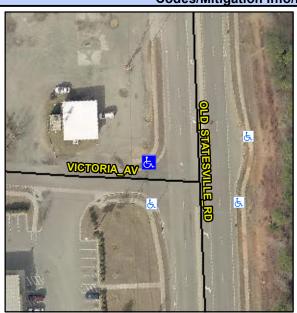
Not Found, R304.5.1, R304.2.2

Compliance Description		Data	Compliance Description		Description	Data
N/A	Ramp Length (in)	60.0	No	Ramp S	Slope (%)	9.7
No	Ramp Width (in)	29.0	Yes	Ramp X	(Slope (%)	2.0
N/A	Flare Type LT	N/A	N/A	Flare Ty	ype RT	N/A
N/A	Flare Slope LT (%)	N/A	N/A	Flare SI	lope RT (%)	N/A
N/A	Flare Traversable LT?	N/A	N/A	Flare Tr	raversable RT?	N/A
N/A	Landing Length (in)	N/A	N/A	DWS P	rovided?	N/A
N/A	Landing Width (in)	N/A	N/A	DWS C	ontrast?	N/A
N/A	Landing Slope (%)	N/A	N/A	DWS L	ength (in)	N/A
N/A	Landing X Slope (%)	N/A	N/A	DWS F	ull Width?	N/A
N/A	Landing Curb? (Y/N)	N/A	N/A	DWS O	Offset (in)	N/A
N/A	Shared Landing?	N/A				
N/A	Gutter Ponding?	N/A	N/A	Gutter S	Slope (%)	N/A
N/A	Gutter Lip Ht (in)	N/A	N/A	Gutter 2	X Slope (%)	N/A
N/A	Painted X Walk1?	No	N/A	Painted	I X Walk2?	No
	X Walk 1 Direction	To S		X Walk	2 Direction	ТоЕ
N/A	X Walk 1 Width (in)	N/A	N/A	X Walk	2 Width (in)	N/A
	X Walk 1 Slope (%)	0.3		X Walk	2 Slope (%)	2.6

X Walk 1 X Slope (%)	1.9		X Walk	2 X Slope (%)	0.2
N/A	Ramp inside XWalk1?	N/A	N/A	Ramp in	nside XWalk2?	N/A
	Road Slope (%)	2.9	N/A	Clear S	pace?	N/A
	Road X Slope (%)	0.9	N/A	Clear S	pace to XWalk (in)	N/A
N/A	Any Obstructions?	N/A	N/A	Storm C	Grate/Utility Hazard?	N/A
	Obstruction Type			Storm C	Grate/Utility Type	
		N/A				N/A
			Yes	Surface	e Condition? (G/P)	Good

Remove & Replace Curb Ramp With Two New Directional Ramps or Equivalent.
