Access Compliance Report

Public Rights-of-Way

(Curb Ramps)

Intersection ID: 11349	Main Street: N_DAVIDSON_ST	Cross Street: PARKWOOD_AV	Location: S
ADA ID: 1F2AE39A39D8	Ramp Type: Perp	Initial Pass/Fail: Fail	Overall Compliance: No
Severity Score: 8.75			
Codes/Mitigation Info/Possible Solution		Field Measurements/Component Compliance

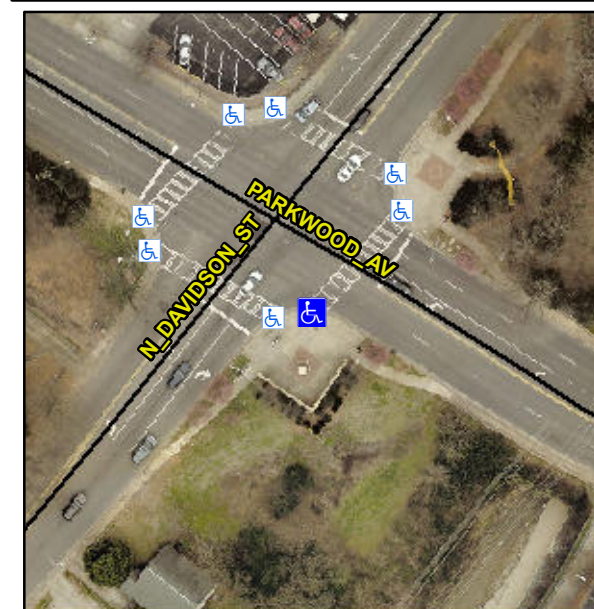
Not Found, R304.5.1

Compliance	Description	Data	Compliance	Description	Data
N/A	Ramp Length (in)	66.5	Yes	Ramp Slope (%)	6.9
No	Ramp Width (in)	47.5	Yes	Ramp XSlope (%)	1.8
N/A	Flare Type LT	N/A	N/A	Flare Type RT	N/A
N/A	Flare Slope LT (%)	N/A	N/A	Flare Slope RT (%)	N/A
N/A	Flare Traversable LT?	N/A	N/A	Flare Traversable RT?	N/A
N/A	Landing Length (in)	N/A	N/A	DWS Provided?	N/A
N/A	Landing Width (in)	N/A	N/A	DWS Contrast?	N/A
N/A	Landing Slope (%)	N/A	N/A	DWS Length (in)	N/A
N/A	Landing X Slope (%)	N/A	N/A	DWS Full Width?	N/A
N/A	Landing Curb? (Y/N)	N/A	N/A	DWS Offset (in)	N/A
N/A	Shared Landing?	N/A			
N/A	Gutter Ponding?	N/A	N/A	Gutter Slope (%)	N/A
N/A	Gutter Lip Ht (in)	N/A	N/A	Gutter X Slope (%)	N/A
N/A	Painted X Walk1?	Yes	N/A	Painted X Walk2?	N/A
	X Walk 1 Direction	To NE		X Walk 2 Direction	N/A
N/A	X Walk 1 Width (in)	107.0	N/A	X Walk 2 Width (in)	N/A
	X Walk 1 Slope (%)	0.5		X Walk 2 Slope (%)	N/A
	X Walk 1 X Slope (%)	0.5		X Walk 2 X Slope (%)	N/A

N/A	Ramp inside XWalk1?	Yes	N/A	Ramp inside XWalk2?	N/A
	Road Slope (%)	N/A	N/A	Clear Space?	N/A
	Road X Slope (%)	N/A	N/A	Clear Space to XWalk (in)	N/A
N/A	Any Obstructions?	N/A	N/A	Storm Grate/Utility Hazard?	N/A
	Obstruction Type			Storm Grate/Utility Type	
		N/A			N/A
		Yes		Surface Condition? (G/P)	Good

Possible Solutions:

Remove & Replace Entire Ramp.
