Access Compliance Report Public Rights-of-Way (Curb Ramps)

Intersection ID: N/A Main Street: E_3RD_ST Cross Street: S_COLLEGE_ST Location: S

ADA ID: 1F2B0C0C046D Ramp Type: BlendTrans1 Initial Pass/Fail: Fail Overall Compliance: No Severity Score: 10

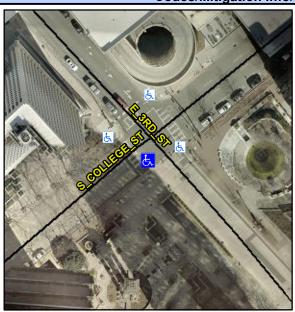
Not Found, R304.5.1, R304.5.3, R304.4.1

Compli		iption Data Compliance Description Da			
Compliance Description					Data
N/A	Ramp Length (in)	53.0	No	BlendTrans Slope (%)	7.7
No	Ramp Width (in)	45.0	No	BlendTrans XSlope (%)	4.0
N/A	Flare Type LT	N/A	N/A	Flare Type RT	N/A
N/A	Flare Slope LT (%)	N/A	N/A	Flare Slope RT (%)	N/A
N/A	Flare Traversable LT?	N/A	N/A	Flare Traversable RT?	N/A
N/A	Landing Length (in)	N/A	N/A	DWS Provided?	N/A
N/A	Landing Width (in)	N/A	N/A	DWS Contrast?	N/A
N/A	Landing Slope (%)	N/A	N/A	DWS Length (in)	N/A
N/A	Landing X Slope (%)	N/A	N/A	DWS Full Width?	N/A
N/A	Landing Curb? (Y/N)	N/A	N/A	DWS Offset (in)	N/A
N/A	Shared Landing?	N/A			
N/A	Gutter Ponding?	N/A	N/A	Gutter Slope (%)	N/A
N/A	Gutter Lip Ht (in)	N/A	N/A	Gutter X Slope (%)	N/A
N/A	Painted X Walk1?	Yes	N/A	Painted X Walk2?	Yes
	X Walk 1 Direction	To NE		X Walk 2 Direction	To NW
	X Walk 1 Width (in)	126.0		X Walk 2 Width (in)	119.0
	X Walk 1 Slope (%)	1.6		X Walk 2 Slope (%)	5.8

X Walk 1 X Slope (%)	5.8		X Walk 2 X Slope (%)	0.8
N/A	Ramp inside XWalk1?	Yes	N/A	Ramp inside XWalk2?	Yes
	Road Slope (%)	3.5		Clear Space?	N/A
	Road X Slope (%)	8.6	N/A	Clear Space to XWalk (in)	N/A
N/A	Any Obstructions?	N/A	N/A	Storm Grate/Utility Hazard?	N/A
	Obstruction Type			Storm Grate/Utility Type	
		N/A			N/A

Remove & Replace Curb Ramp With Two New Directional Ramps or

Total Cost: \$ 3200.00
